ARBORICULTURAL SURVEY FOR A PROPOSED MIXED-USE DEVELOPMENT AT MARRIOTT'S PARK, TAVERHAM, NORFOLK, NR8 6HL

Report Reference Number: Project Number: Issue Number: Issue Date:

3551,EC,AR,DS/P2 ARB/RF,KL/04-12-18/V1 3551,EC,AR,DS 1 04 December 2018

| Report Number: | 3551,EC,AR,DS,/P2 ARB/RF,KL/04-12-18/V1 | | |
|---|--|---|---|
| Report Type: | Arboricultural Survey | | |

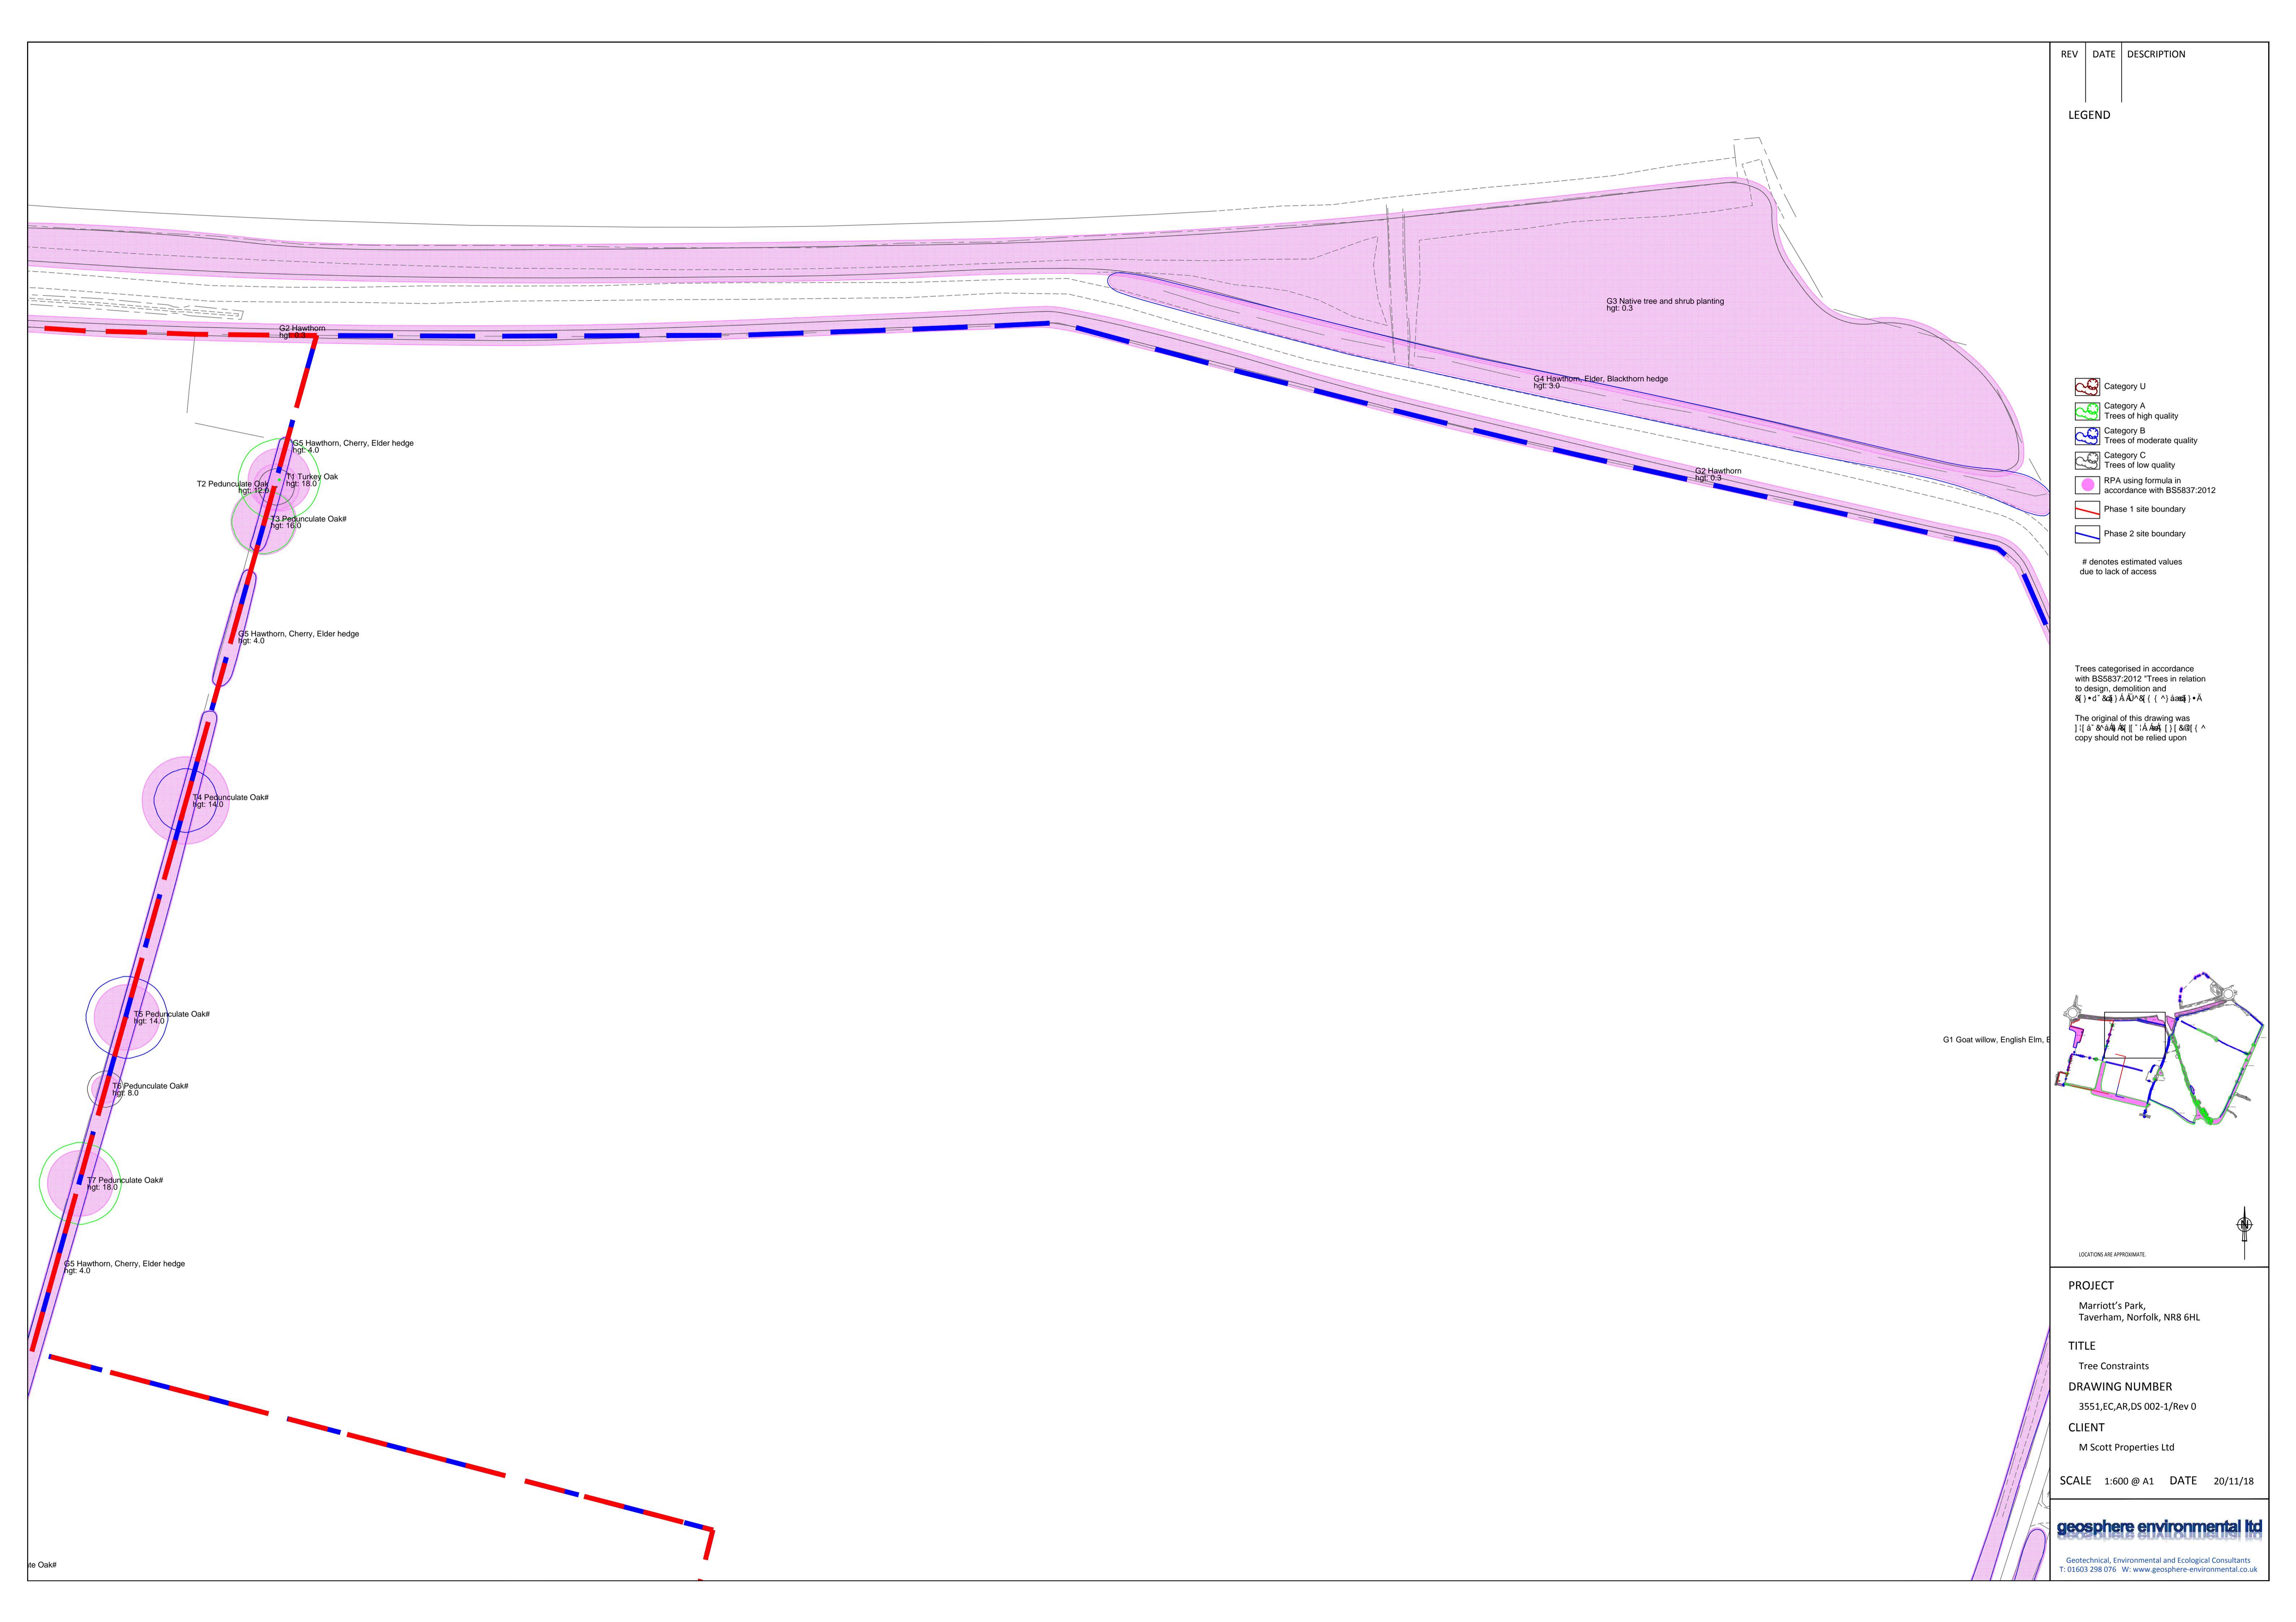
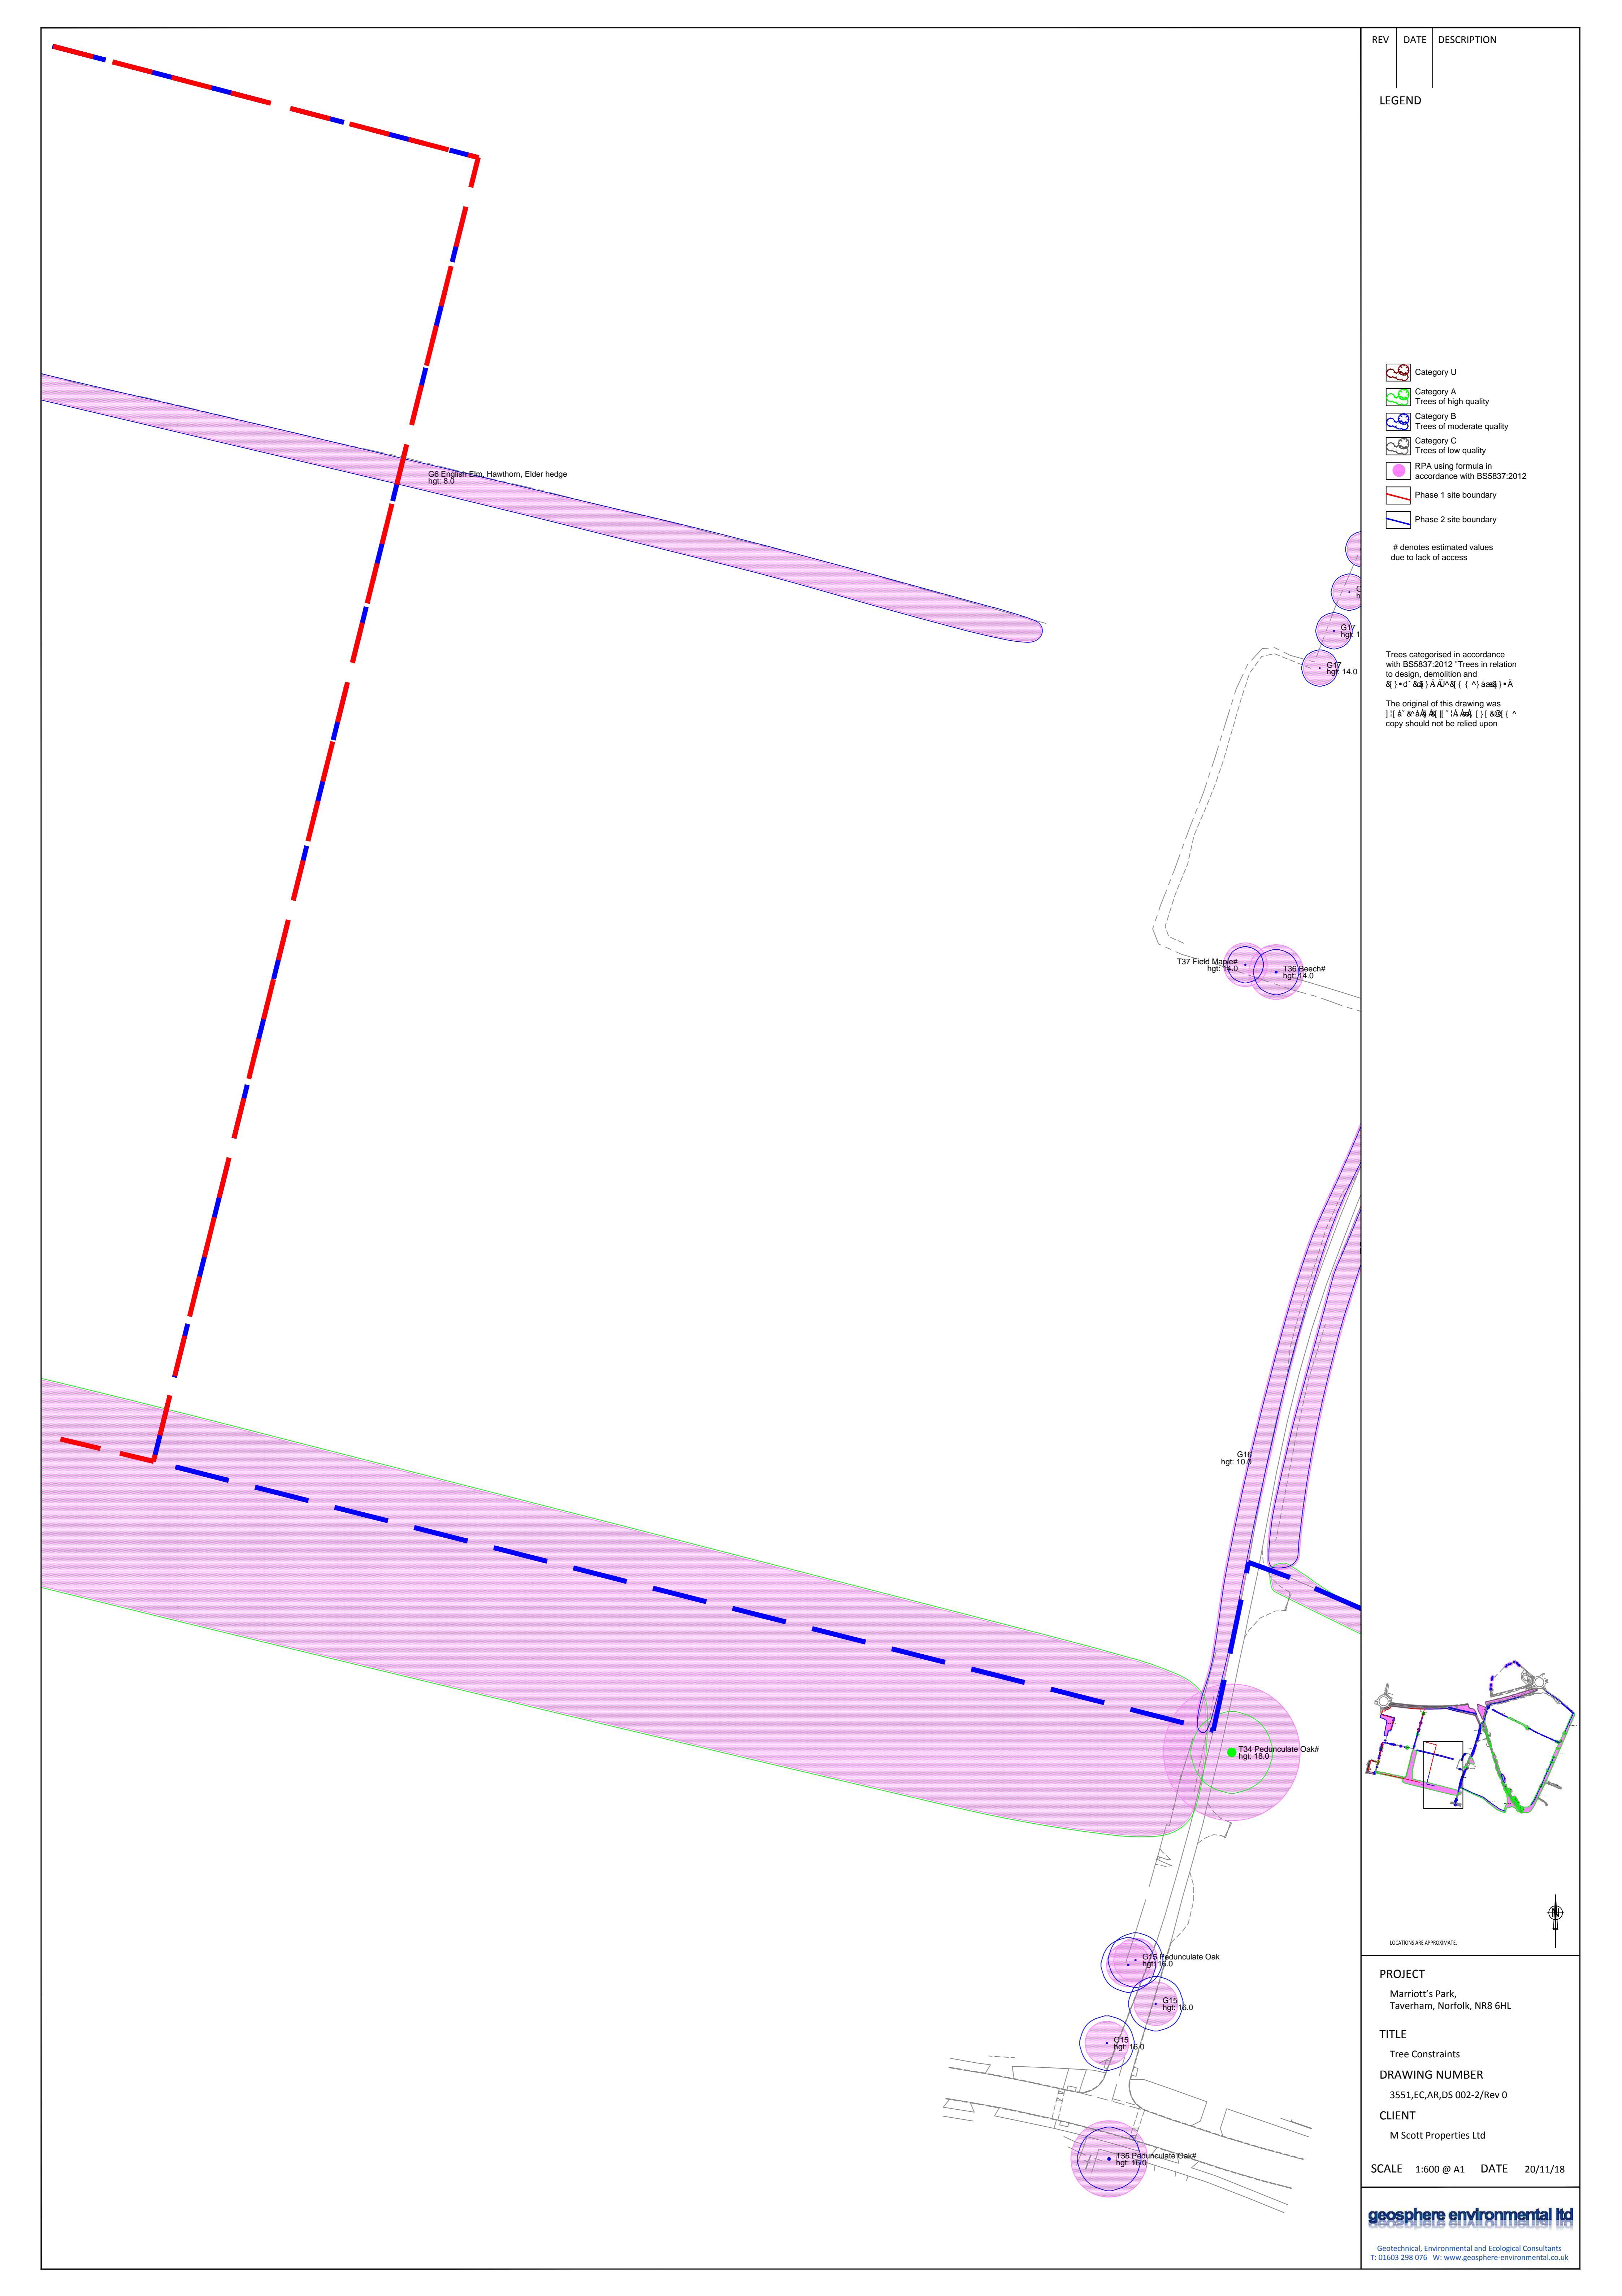
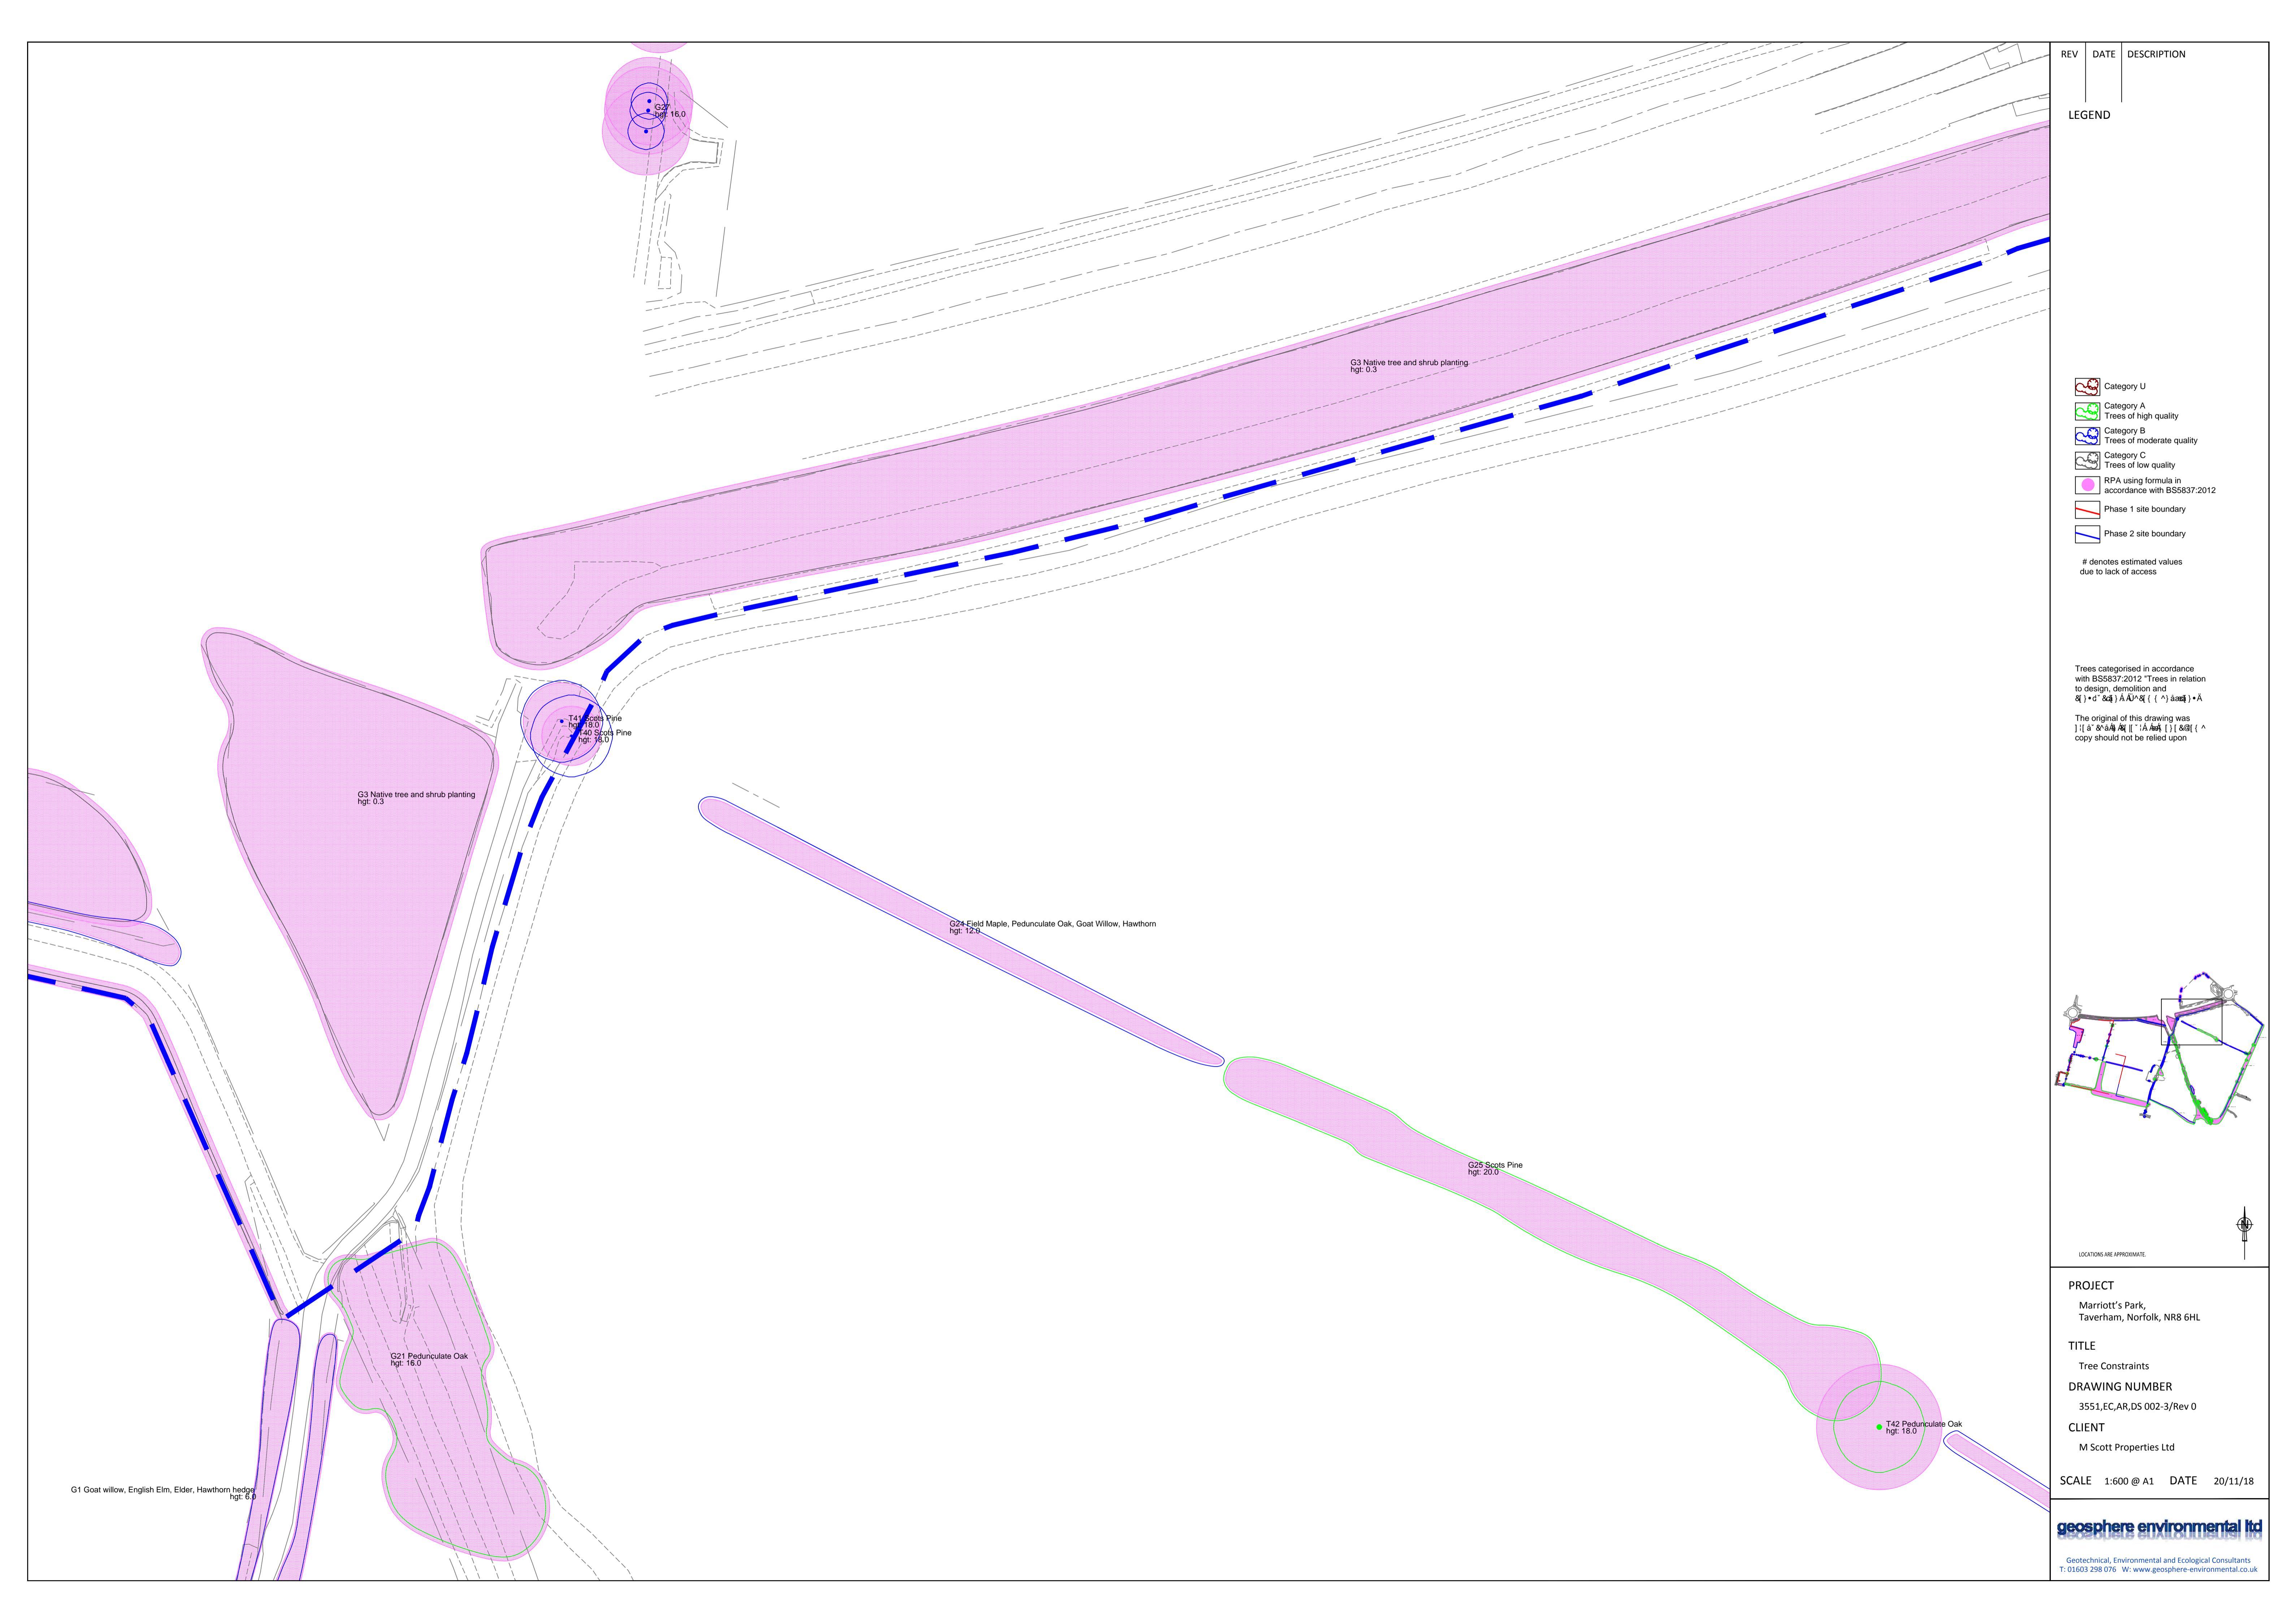
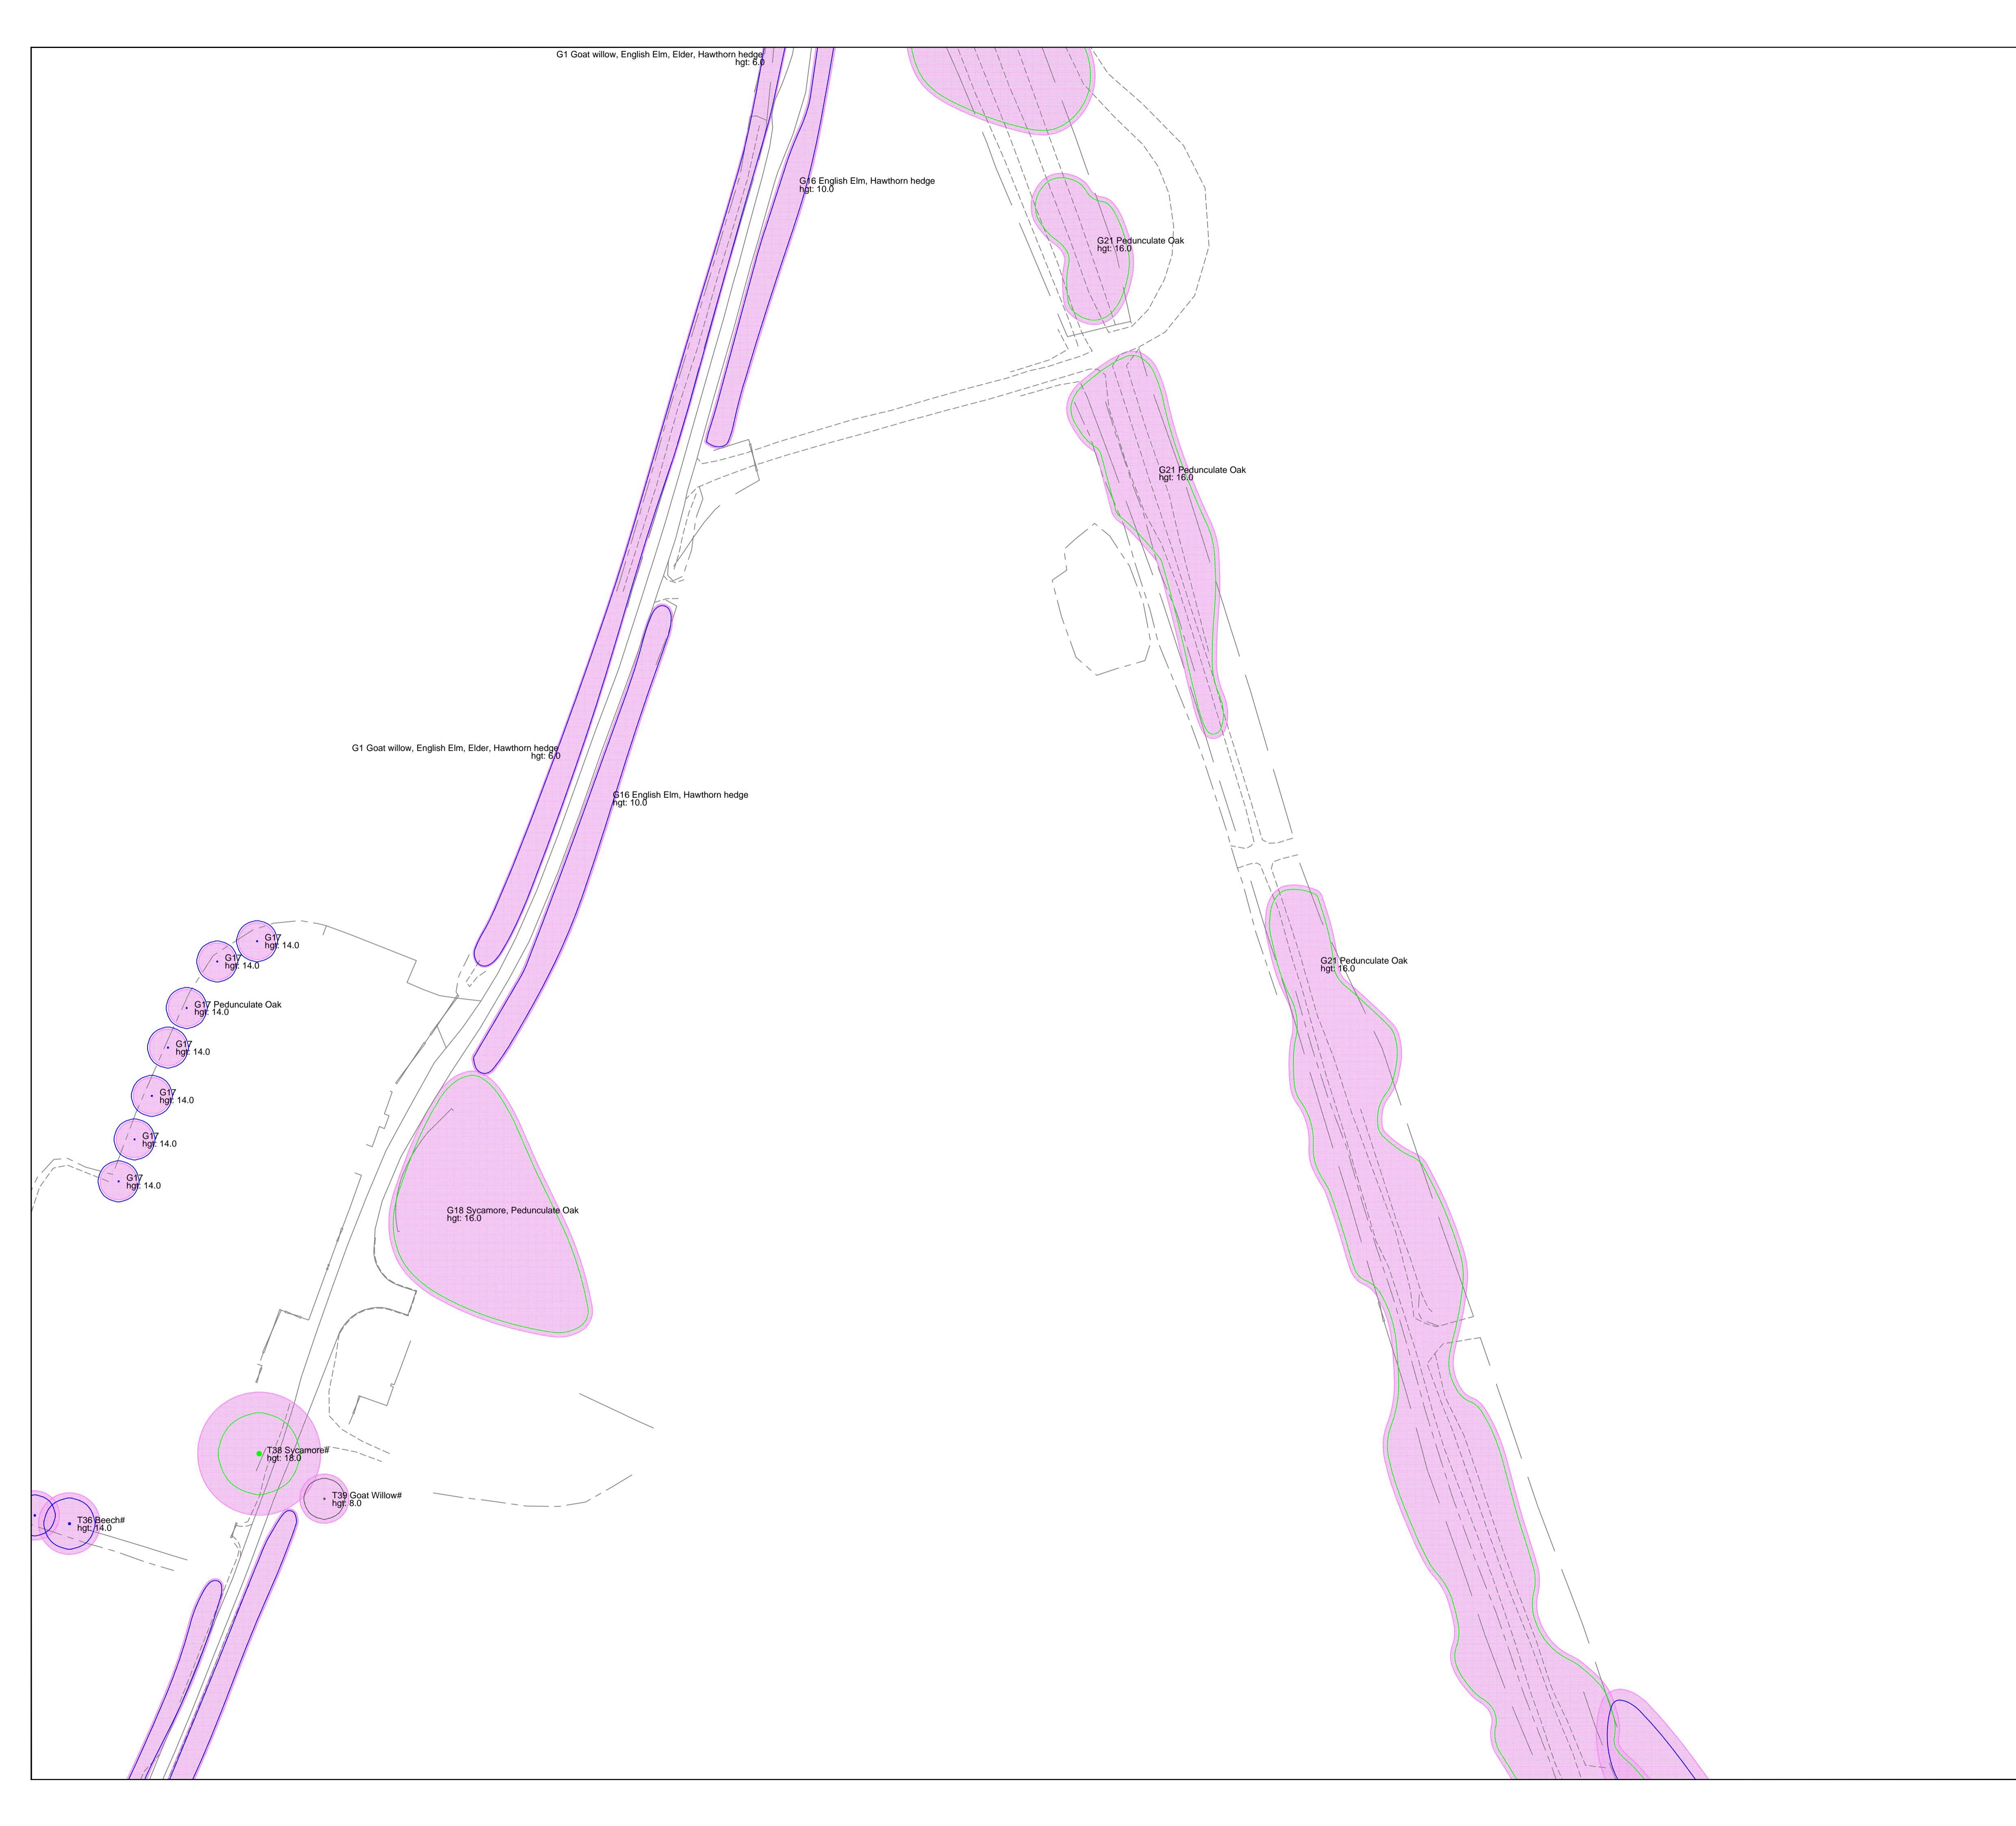
Tree Constraints Plan – Drawing Ref. 3551, EC/002–1–8/Rev 0

| Report Description | Geosphere Environmental Limited was commissioned by M Scott Properties Ltd, to undertake an arboricultural survey of Marriott's Park, Taverham, Norfolk, NR8 6HL. |
|---|--|
| Summary of Main Findings | The Tree Constraints Plan Drawing ref. 3551,EC,AR,DS/002/Rev 0 in Appendix 6, shows the locations of all the trees surveyed with the canopy and root protection area plotted on the plan. |

The Tree Constraints Plan describes the constraints that the trees may place on the development. The tree canopy and root protection area have been calculated using the stem diameter as per BS 5837:2012 (ref. **R.1**).

The trees which line Marriott's Way (G21) are also considered category A trees. There are two existing tracks which pass through the line of trees. Any new roads or service runs should be designed to use these existing access points to avoid further impact to the trees. Of the trees along Marriott's Way, the most important trees have been recorded as G22, located to the south of Marriott's way. The proposals should be designed to avoid work within the root protection areas of these trees.

Breck Farm Lane enters the site from the south. This lane is narrow, with trees lining the lane (G15 and T34). It will be difficult to widen the junction with Kingswood Avenue and entrance of the road, without impacting or removing these trees. Further along the lane, the hedgerows (G16 and G1) are overrun with ivy and bramble, contains small dead elm trees and large gaps. If required, the hedgerows at this point could be re-located in order to widen the road.

The Tree Constraints Plan Drawing ref. 3551, EC/002/Rev 0 in Appendix 6 should be consulted, to ensure that the constraints posed by the trees are taken into account when designing the proposed development.
