PRELIMINARY ARBORICULTURAL SURVEY  
FOR A PROPOSED RESIDENTIAL DEVELOPMENT AT  
BRIAR FARM: LAND OFF MENDHAM LANE, HARLESTON,  
NORFOLK, IP20 9DW

Report Reference Number: 3495,EC,AR,DS/ARB/LT,RF,KL/13-12-18/V2  
Project Number: 3495,EC,AR,DS  
Issue Number: 2  
Issue Date: 13 December 2018

Report Description	<p>Geosphere Environmental Limited was commissioned by M Scott Properties Ltd, to undertake a preliminary arboricultural survey of Briar Farm: Land off Mendham Lane, Harleston, Norfolk, IP20 9DW.</p> <p>The site is located at National Grid Reference (NGR) 625260 282920. The report relates to the proposed redevelopment of the site for residential and commercial use with associated access roads.</p> <p>The site covers an area of approximately 27.13 hectares (ha). This and the immediate surrounding area were surveyed.</p>
Summary of Main Findings	<p>The Preliminary Tree Constraints Plan, Drawings refs. 3495,EC,AR,DS/003-1/Rev 0 and 3495,EC,AR,DS/003-2/Rev 0 in Appendix 6, show the locations of all the trees surveyed and their categories.</p> <p>A total of 41 trees and 29 groups of trees were surveyed.</p> <p>Twenty-three trees were classed as Category A trees. Nine trees and ten

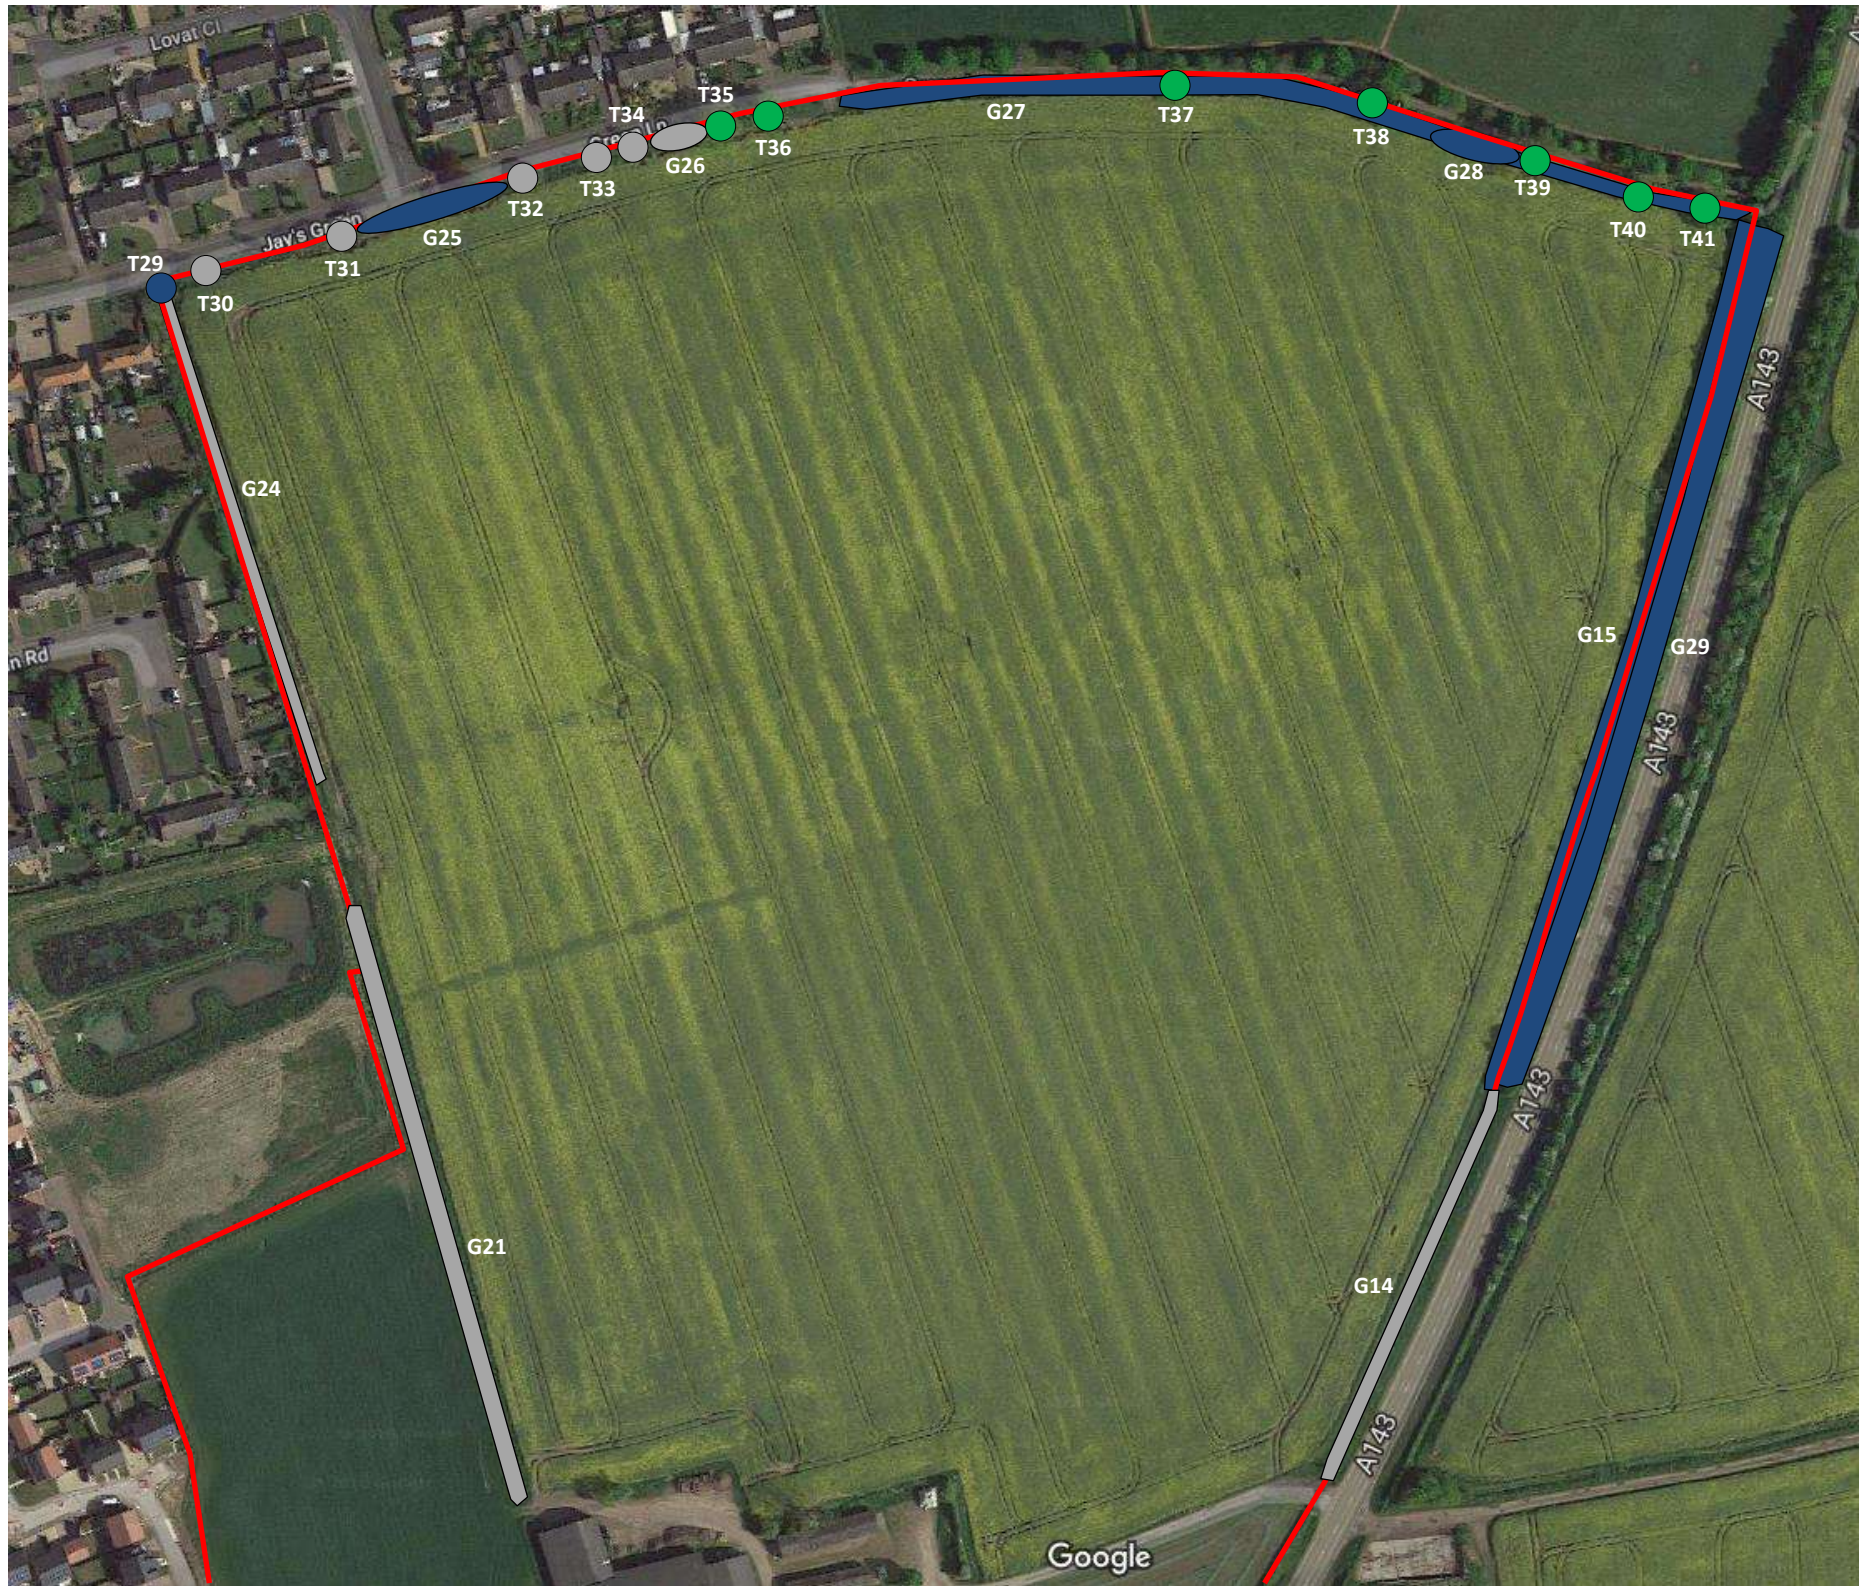
**DRAWING NO.**  
 003-1 / Rev 0  
**CHECKED**  
 KML

The trees have been categorised accurately, and the approximate location of these trees is shown on the Tree Constraints Plan Drawing refs. 3495,EC,AR,DS/003-1/Rev 0 and 3495,EC,AR,DS/003-2/Rev 0 in Appendix 6.

The Preliminary Tree Constraints Plan shows the locations of the trees surveyed and their categories to assist with the design of the final development.

The Preliminary Tree Constraints Plan, Drawing refs. 3495,EC,AR,DS/003-1/Rev 0 and 3495,EC,AR,DS/003-2/Rev 0 in Appendix 6, should be consulted to assist with designing the final proposed development.
