Hopkins Homes

Greater Norwich Local Plan

Land at Beccles Road, Loddon

Representations to Stage C Regulation 18 Consultation

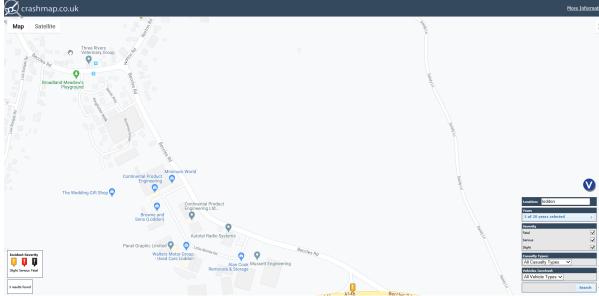
Figure 2. Collisions in the vicinity of the site over the past five years

- The occasions when more than one access point will be considered are:
- Where the site is so constrained so as not to be able to provide adequate on-site turning facilities.
- Where the development site is very large in scale requiring on-site traffic."
- 4.5.5 This guidance also suggests that each proposal should be dealt with on its own merits and that standards should not be used inflexibly.
- 4.5.6 The Crashmap website has been reviewed, to identify collisions on the local highway network, as well as their severity, over the past five-year period. **Figure 2** indicates that there are have not been any collisions on Beccles Road in the vicinity of the site over the past five years.

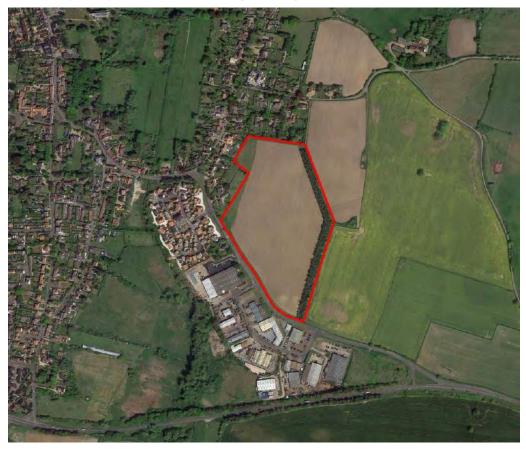
Figure 2. Aerial Image

- 3.1.1 The site situated off Beccles Road, Loddon, is located on sloping ground on the eastern side of a tributary of the River Chet, which runs directly south to north and joins the Chet approximately 400 metres north-east of the town centre. The site is currently a single arable field of approximately 7.6 hectares, bounded on the eastern and north-eastern sides by a 20 metre-wide tree plantation. The plantation is approximately 20 years old and of mixed deciduous and coniferous trees about 8 metres high. Along the eastern side of the plantation are a number of mature Oak trees.
- 3.1.2 The site fronts onto Beccles Road with an established hedgerow, primarily Hawthorn, and maintained at a height of approximately 2 metres. Between the hedgerow and the highway is a footpath/cycleway and a 2 metre-wide grass verge.

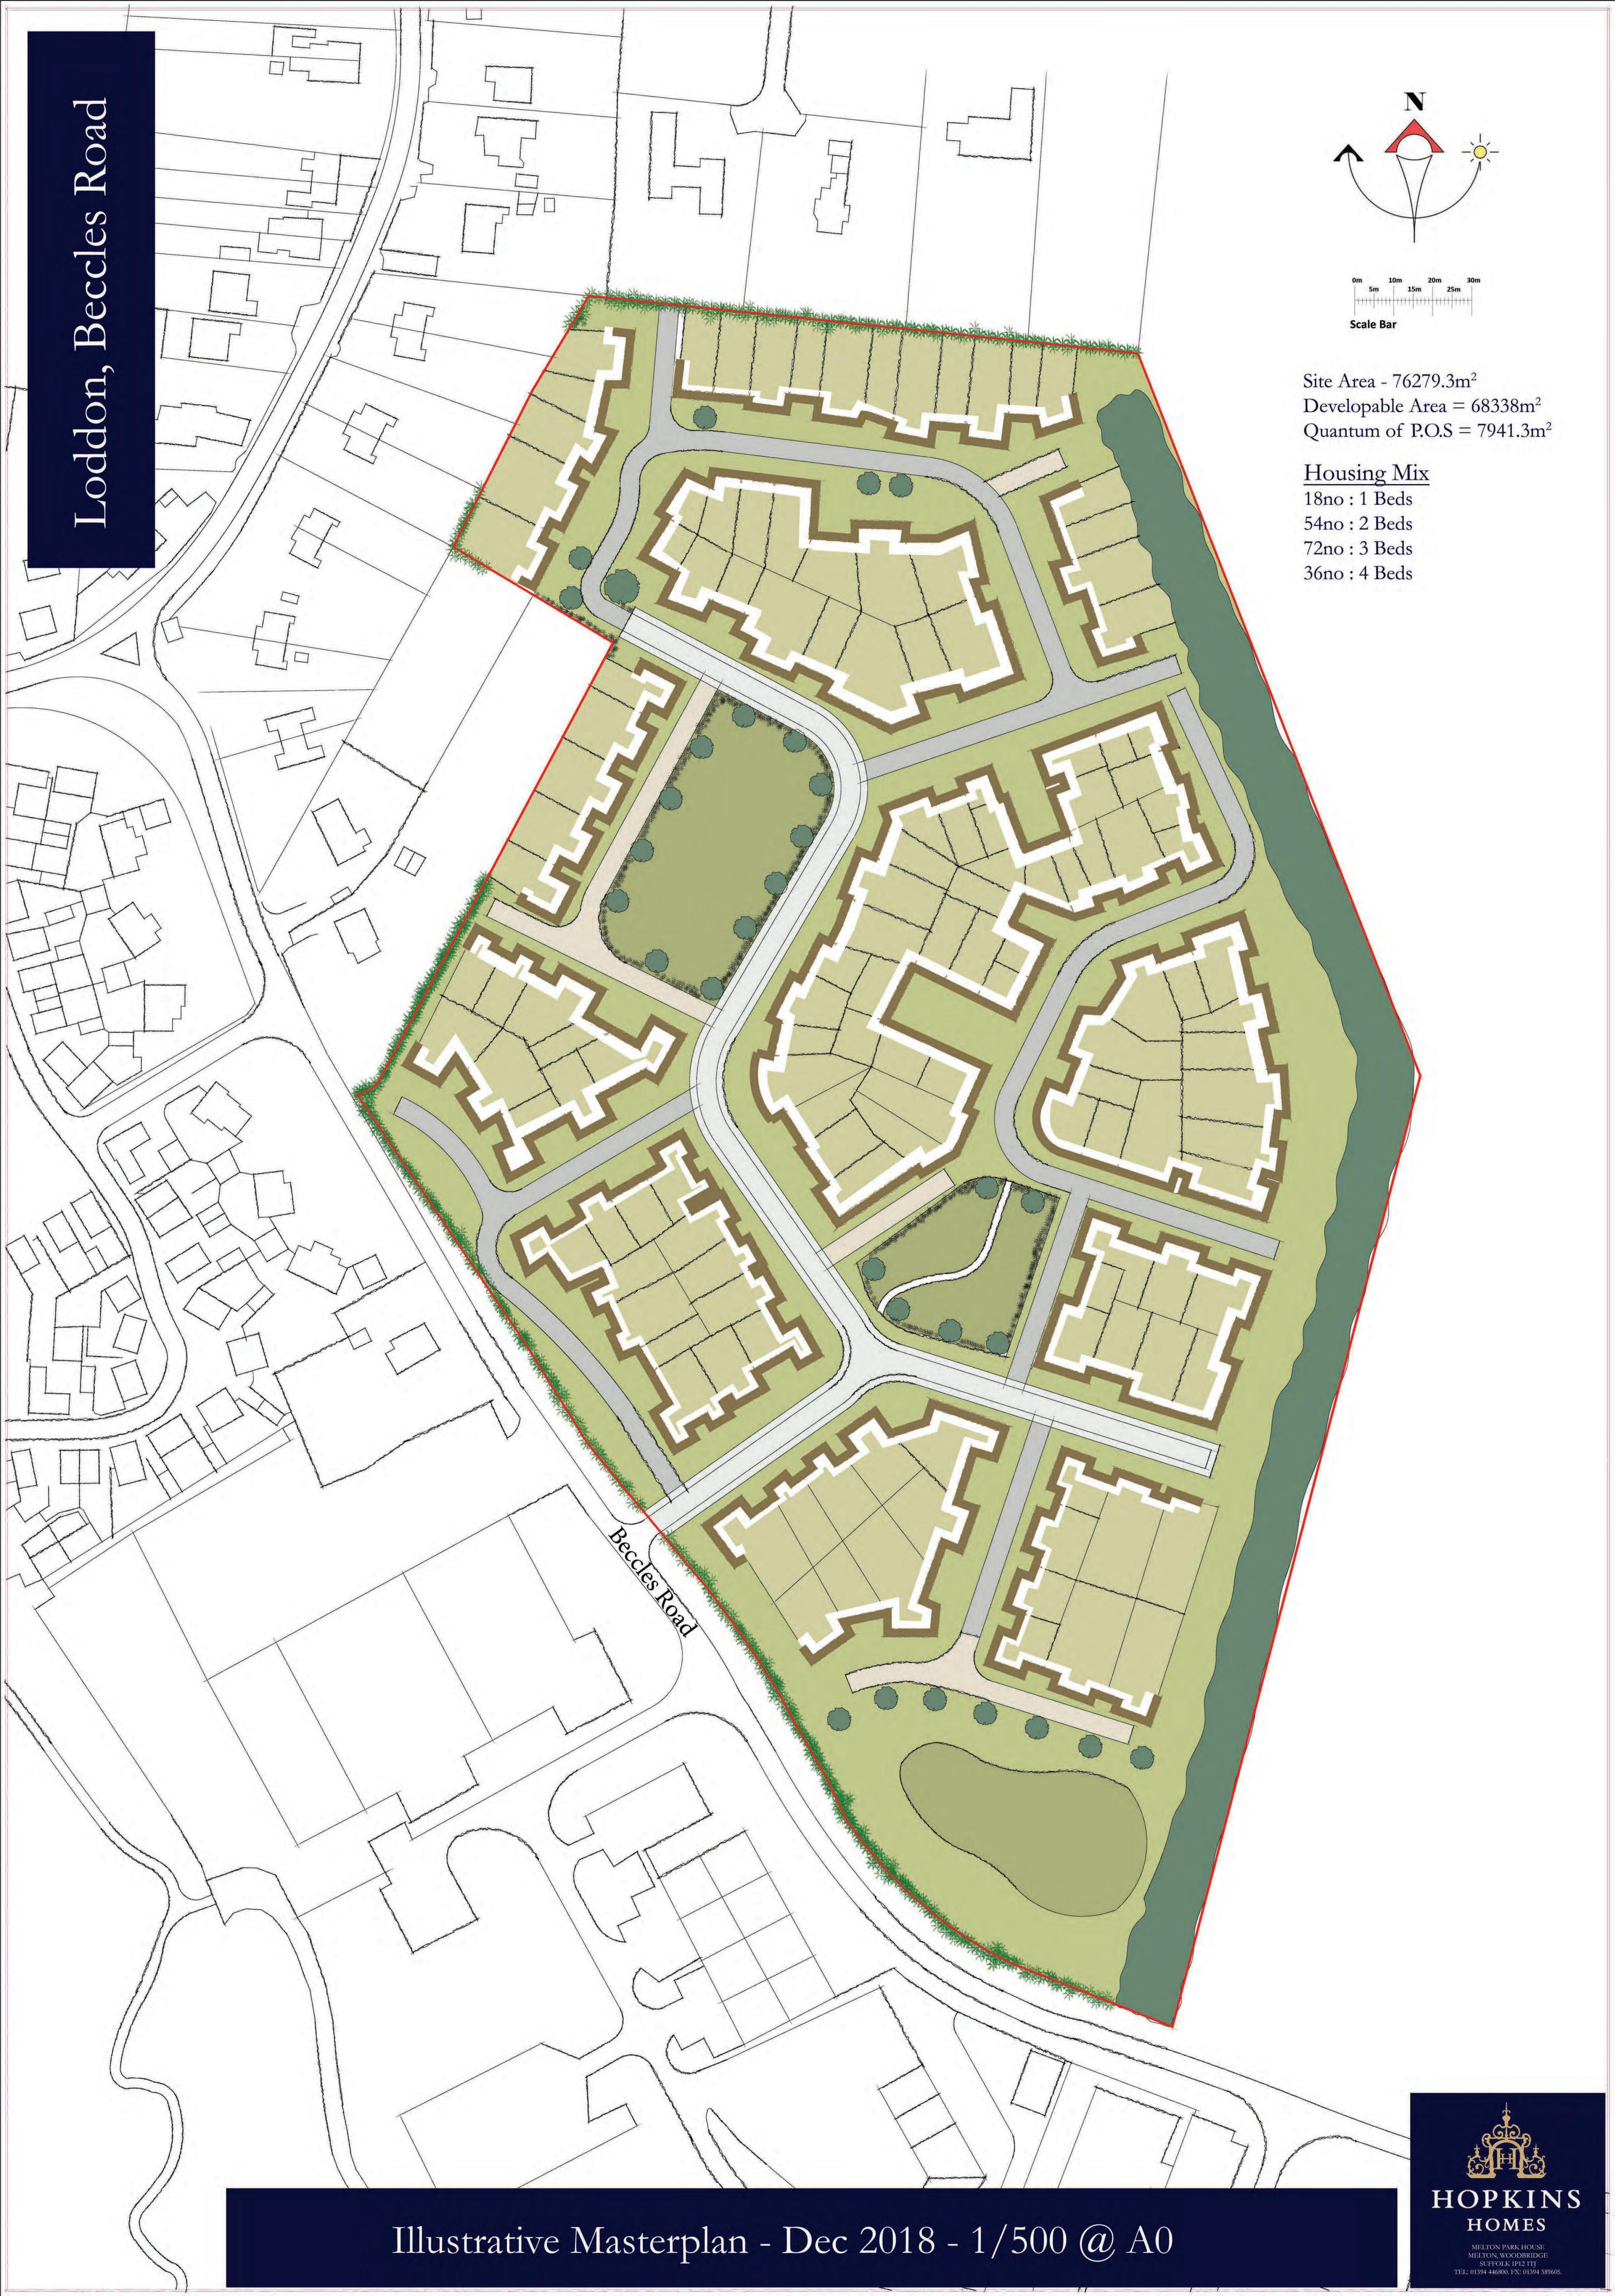
Appendix 1 – Illustrative Masterpl	an
------------------------------------	----

- 7.1 The proposal comprises residential development, open space, gardens and associated road and path infrastructure for approximately 180 dwellings. The indicative layout is shown on the following page.
- 7.2 The total site area is approximately 7.63 hectares, of which 0.79 ha is proposed public open space
- 7.3 The proposed housing mix comprises the following:
 - 18 no. 1 Bedroom
 - 54 no. 2 Bedrooms
 - 72 no. 3 bedrooms
 - 36 no. 4 bedrooms

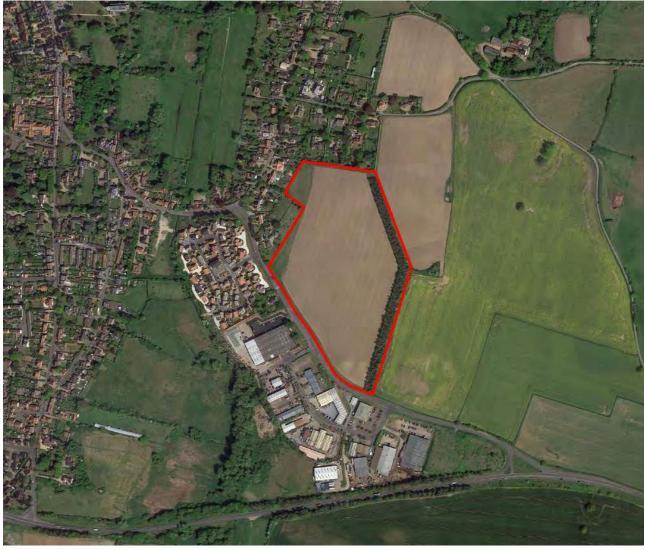
Aerial view of the application site

- 1.9 The site off Beccles Road Loddon is located on sloping ground on the eastern side of a tributary of the River Chet, which runs directly South to North and joins the Chet approximately 400 metres north-east of the town centre. The site is currently a single arable field of approximately 7.6 hectares, bounded on the Eastern and North-eastern sides by a 20 metre-wide tree plantation. The plantation is approximately 20 years old and of mixed deciduous and coniferous trees about 8 metres high. Along the eastern side of the plantation area number of mature Oak trees, marking the former
- 1.10 The site fronts onto Beccles Road with an established hedgerow, primarily Hawthorn, and maintained at a height of approximately 2 metres. Between the hedgerow and the highway is a footpath/cycleway and a 2 metre-wide grass verge.

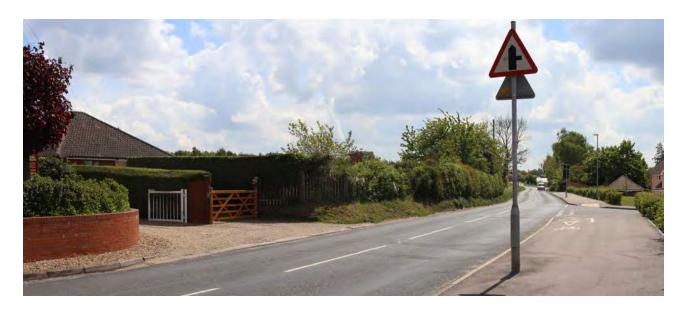
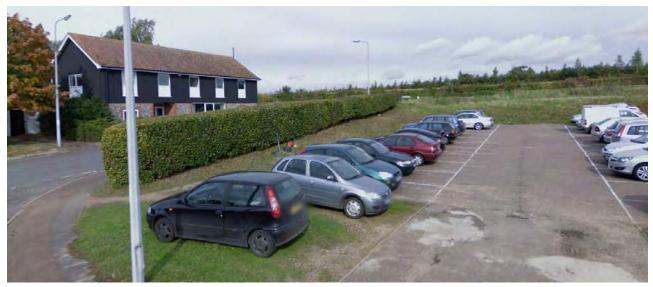
Top: View south-eastwards from Beccles Road, close to the Western corner of the site. Bottom: View eastwards from the Industrial Estate on Little Money Road

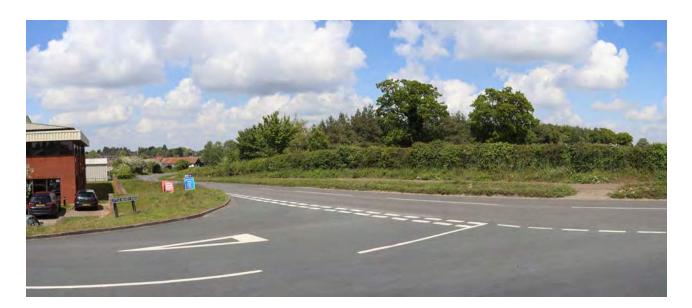
Top: View Northwards from the Beccles Road/ Little Money Road junction towards the tree belt around the site

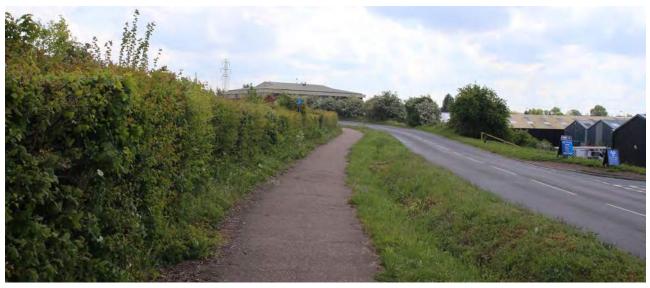
Bottom: View South-eastwards along the edge of the site on Beccles Road, with the hedgerow boundary on the left-hand side

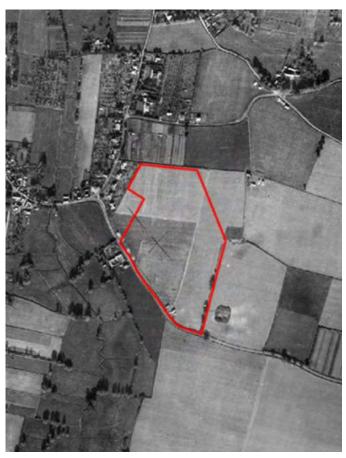
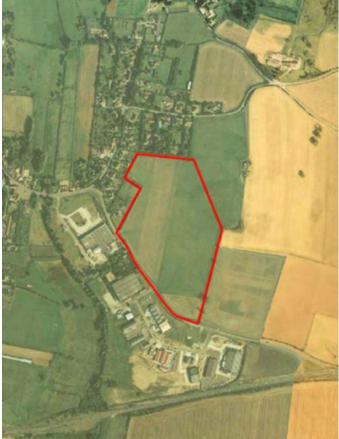
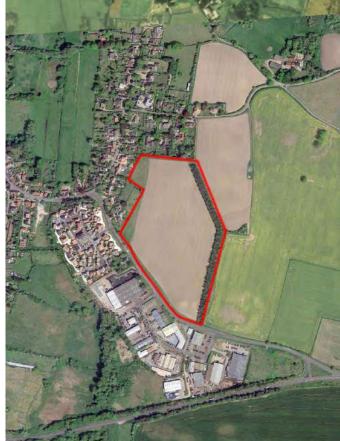
Historic mapping. Top left: Ordnance Survey c. 1890. Top right: Aerial 1946 Bottom left: Aerial 1988. Bottom right: Aerial 2010

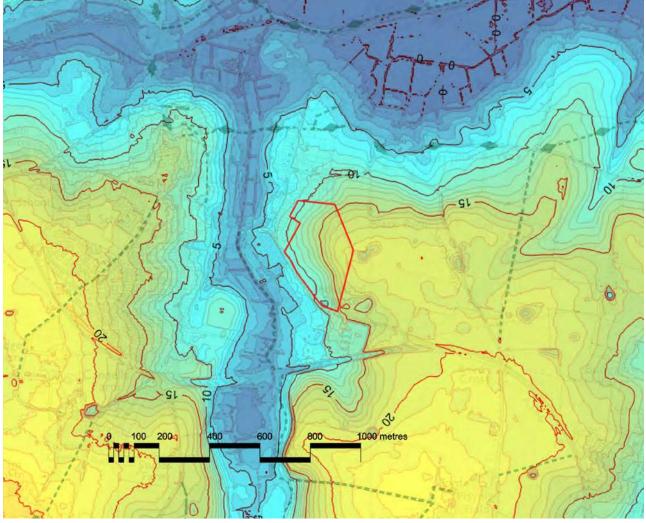
Local topography

- 6.1 An analysis of the topography demonstrates the district topography of the area.
- The Site slopes gently down roughly from south east to north west, with levels of just over 19m AOD (above Ordnance Datum, or mean sea level) on the eastern side, falling to around 10m AOD along Beccles Road to the west. It is located on the eastern side of the valley of a stream which drains into the River Chet to the north.
- As noted in the District Landscape Character Assessment this is an area with landform which slopes gradually upwards from the River Chet and low-lying Broads in the north east at Loddon and Chedgrave to higher ground towards the south and south west. The small tributary river has an obvious influence in the landscape, with associated features include pockets of pasture, road bridges, village ponds and willow trees.

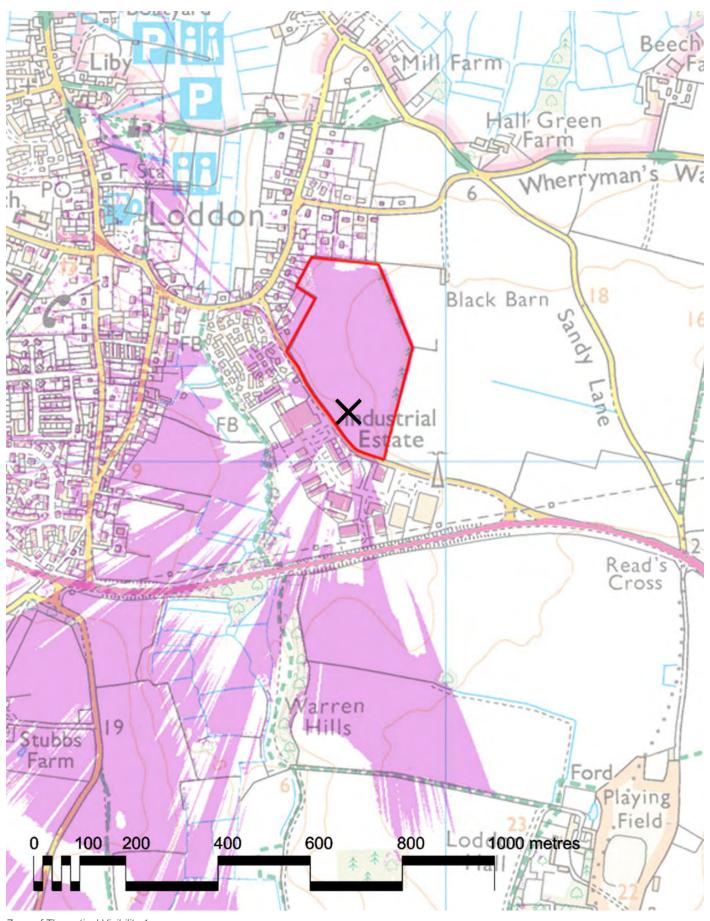
Zone of Theoretical Visibility 1

- 8.5 The ZTV suggests that the 8 metre-high woodland belt will almost completely screen the site for all viewers to the east. There is a cone of visibility directed toward the south and south-west, where the development is potentially visible. This was more thoroughly assessed on site.

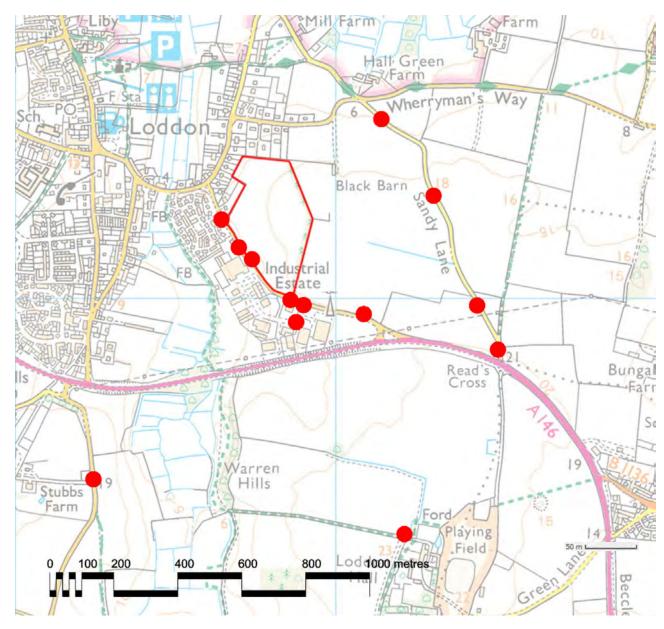
Site plan showing the location of the viewpoints for the visual analysis

- 9.1 The application site and its environs were walked and driven over one day to determine potential views of the proposed development, and identify key locations (receptors) where the visual impact may be considered significant and where the landscape character might be affected.
- 9.2 Photographs have been used to demonstrate the key views and vistas, and to indicate potential visibility to and from the proposed development site. The location of the viewpoints was logged using a handheld GPS unit, to provide co-ordinated with 4 metre accuracy and this data was used to prepare the panoramic visualisations which were used in the preparation of the proposals. The following section summarises the key visual impacts.

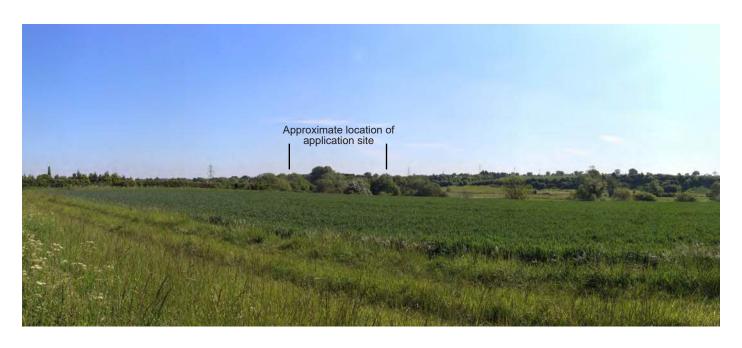
Grid ref: TG2348302155

Viewpoint 1	Sensitivity	Description of effects	Magnitude of visual effect	Significance
View north- eastwards from Dull's Road, approximately 820 metres from the application site	Medium/High This is the view from a public road with open views of a valued valley landscape	The site is largely screened, although the roofs of buildings on the upper part of the site will be visible just below the distant wooded ridge, particularly during winter	Minor due to the effects of distance	Minor

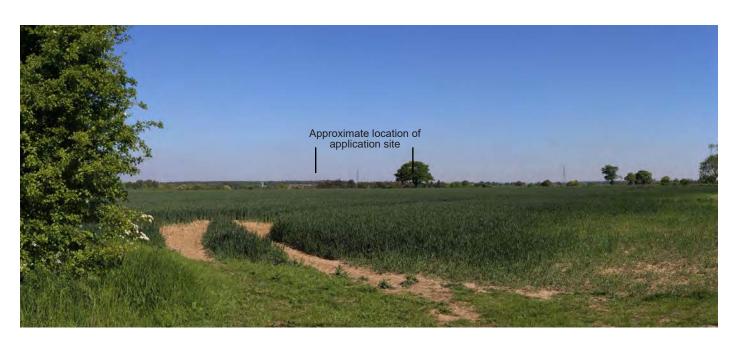
Grid ref: TG2346002167

Viewpoint 2	Sensitivity	Description of effects	Magnitude of visual effect	Significance
View northwards from the public right of way running westwards from Hales Green near Loddon Hall, approximately 870 metres from the application site	High This is the view from a public footpath within an area of high landscape value	The proposed development is screened by topography and intervening trees and woodland. Further west, the footpath is completely enclosed by dense hedgerow, screening all views outward	None - the proposals will not affect the view	None

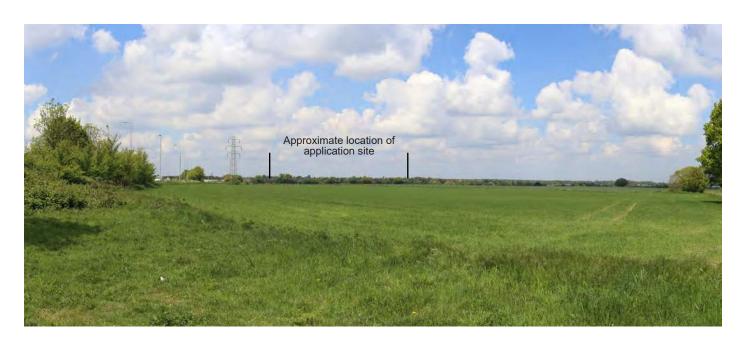
Grid ref: TG2341502193

Viewpoint 3	Sensitivity	Description of effects	Magnitude of visual effect	Significance
View westwards from Sandy Lane, approximately 685 metres from the application site	Medium This is a view over a rural landscape of good quality from a public road,	The site is enclosed by field boundaries and tree belts, separating it from the agricultural landscape beyond and screened from this direction.	None - the proposals will not affect the view	None

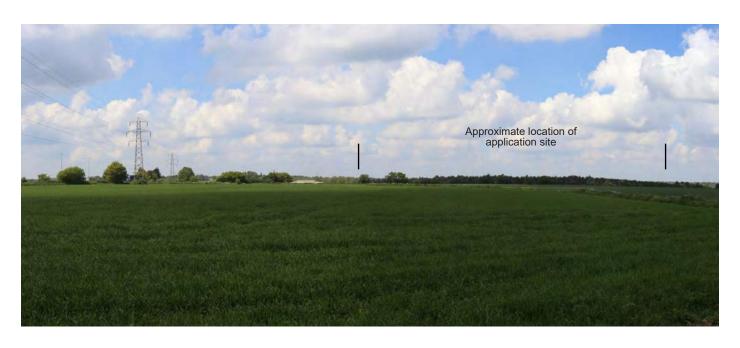
Grid ref: TG2341202199

Viewpoint 4	Sensitivity	Description of effects	Magnitude of visual effect	Significance
View westwards from Sandy Lane, approximately 580 metres from the application site	Medium This is a view over a rural landscape of good quality from a public road,	The site is enclosed by field boundaries and tree belts, separating it from the agricultural landscape beyond and screened from this direction.	None - the proposals will not affect the view	None

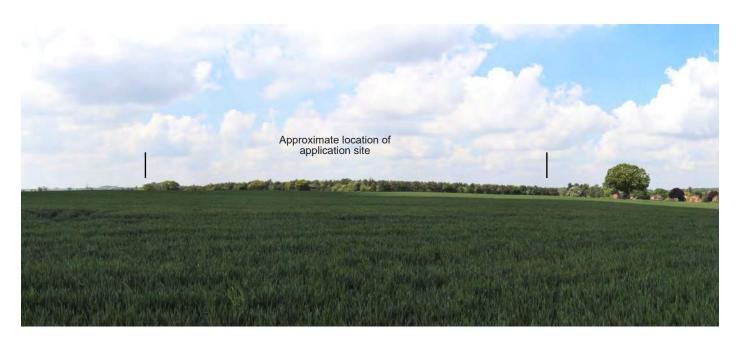
Grid ref: TG2340902175

Viewpoint 5	Sensitivity	Description of effects	Magnitude of visual effect	Significance
View westwards from Sandy Lane, approximately 395 metres from the application site	Medium This is a view over a rural landscape of good quality from a public road,	The site is enclosed by field boundaries and tree belts, separating it from the agricultural landscape beyond and screened from this direction.	None - the proposals will not affect the view	None

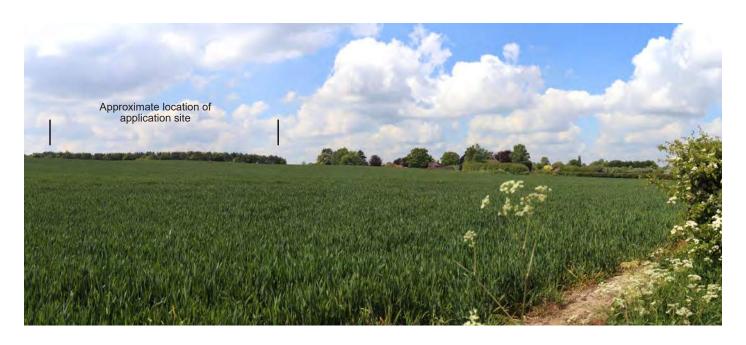
Grid ref: TG2338202183

Viewpoint 6	Sensitivity	Description of effects	Magnitude of visual effect	Significance
View South- westwards from Sandy Lane, approximately 335 metres from the application site	Medium This is a view over a rural landscape of good quality from a public road,	The site is enclosed by field boundaries and tree belts, separating it from the agricultural landscape beyond and screened from this direction by topography and vegetation.	None - the proposals will not affect the view	None

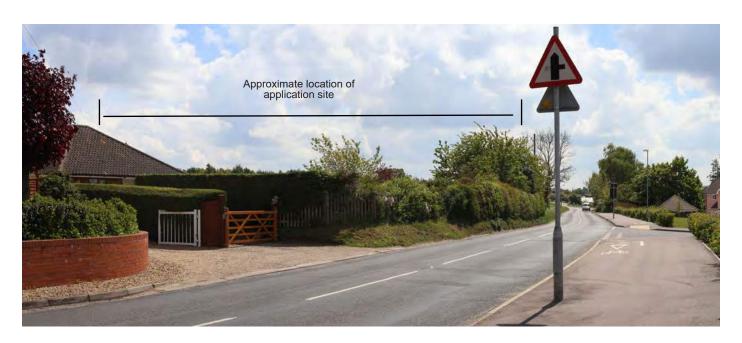
Grid ref: TG2336302132

Viewpoint 7	Sensitivity	Description of effects	Magnitude of visual effect	Significance
View south- eastwards from Beccles Road, approximately 60 metres from the western corner of the application site	Medium/High This is a view from a public road in a residential area close to the edge of the Conservation Area	This is a transitional area, between the historic core of the town and the more urban fringe area, with the commercial estate and recent housing development on the right-hand side. The new development will be visible beyond garden boundaries, although the impact and the quality of that impact will depend on building heights, density and design	Moderate	Moderate

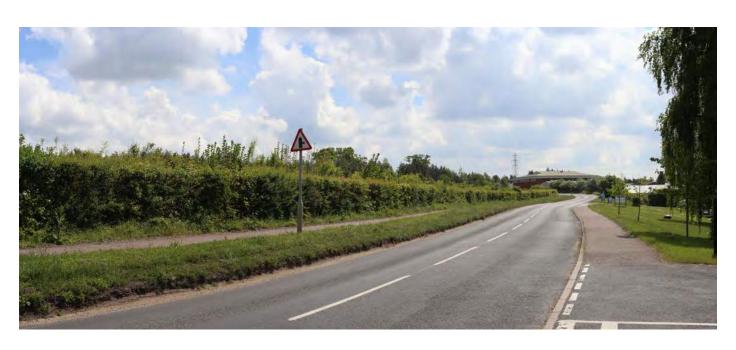
Grid ref: TG2334402143

Viewpoint 8	Sensitivity	Description of effects	Magnitude of visual effect	Significance
View south- eastwards from Beccles Road, with the hedgerow on the application site boundary visible on the left hand side	Medium	There are views here over the arable field up toward the plantation surrounding the site. New development here will change the character of the site, although the nature of that change will depend on the quality of the design. Retention of existing landscape features, such as the existing hedgerow (with allowances for visibility splays and entrances), will ensure a robust landscape structure to contain the new development	Major	Major

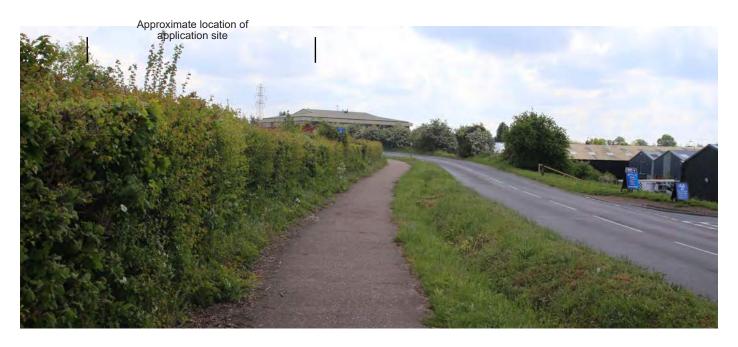
Grid ref: TG2332102166

Viewpoint 9	Sensitivity	Description of effects	Magnitude of visual effect	Significance
View south- eastwards from the eastern side of Beccles Road, with the hedgerow on the application site boundary visible on the left hand side	Medium	There are views here over the arable field up toward the plantation surrounding the site, and over the commercial area to the west. New development here will change the character of the site, although the nature of that change will depend on the quality of the design. Retention of existing landscape features will be important, such as the existing hedgerow (with allowances for visibility splays and entrances)	Major	Major

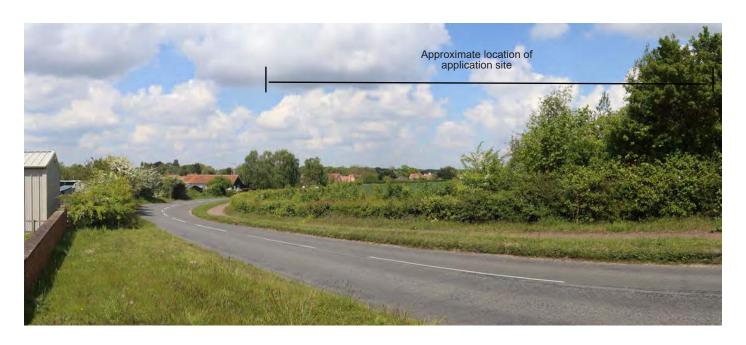
Grid ref: TG2331102234

Viewpoint 10	Sensitivity	Description of effects	Magnitude of visual effect	Significance
View northwards from Beccles Road, with the hedgerow on the application site boundary visible on the right hand side, and the commercial estate on the left	Medium	There are views here over the arable field up toward the plantation surrounding the site. New development here will change the character of the site, although the nature of that change will depend on the quality of the design. Retention of existing landscape features will be important, such as the existing hedgerow (with allowances for visibility splays and entrances)	Moderate	Moderate

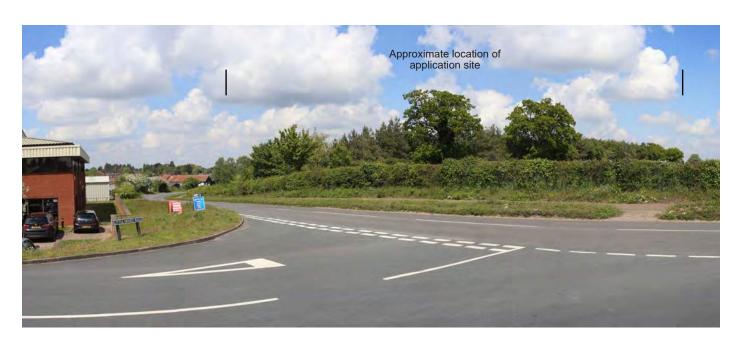
Grid ref: TG2331102233

Viewpoint 11	Sensitivity	Description of effects	Magnitude of visual effect	Significance
View northwards from Beccles Road, with the plantation on the application site boundary visible on the right hand side, and the commercial estate on Little Money Road on the left	Medium	The site is largely screened by the plantation and veteran boundary Oak trees.	Negligible	Negligible

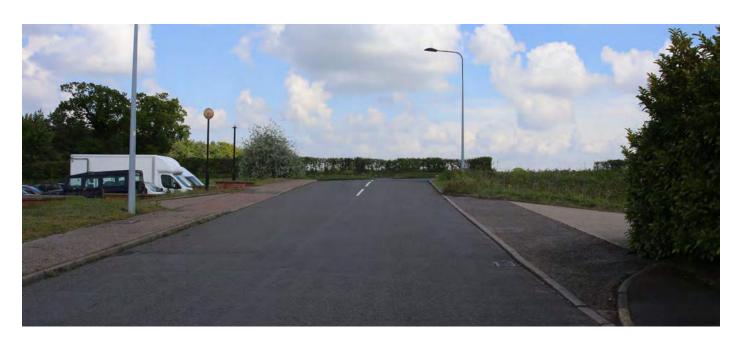
Grid ref: TG2303302102

Viewpoint 12	Sensitivity	Description of effects	Magnitude of visual effect	Significance
View northwards from the commercial estate on Little Money Road	Low	The site is largely screened by the plantation and veteran boundary Oak trees.	Negligible	Negligible

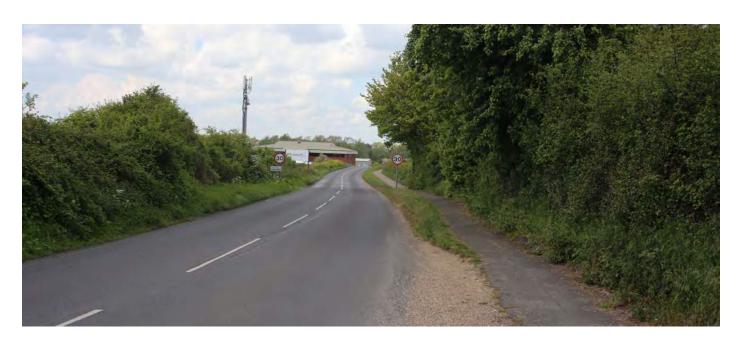
Grid ref: TG2303702046

Viewpoint 13	Sensitivity	Description of effects	Magnitude of visual effect	Significance
View northwards along Beccles Road, approximately 240 metres from the application site	Low This is a view from a busy road close to the A146	The application site is screened by local topography and landscape features	None	None
