Land at Tuttle Lane

TUTTLES LANE DEVELOPMENT BRIEF_SCHOOL OPTION

Arboricultural Appraisal

Work **Ecology Assessment**

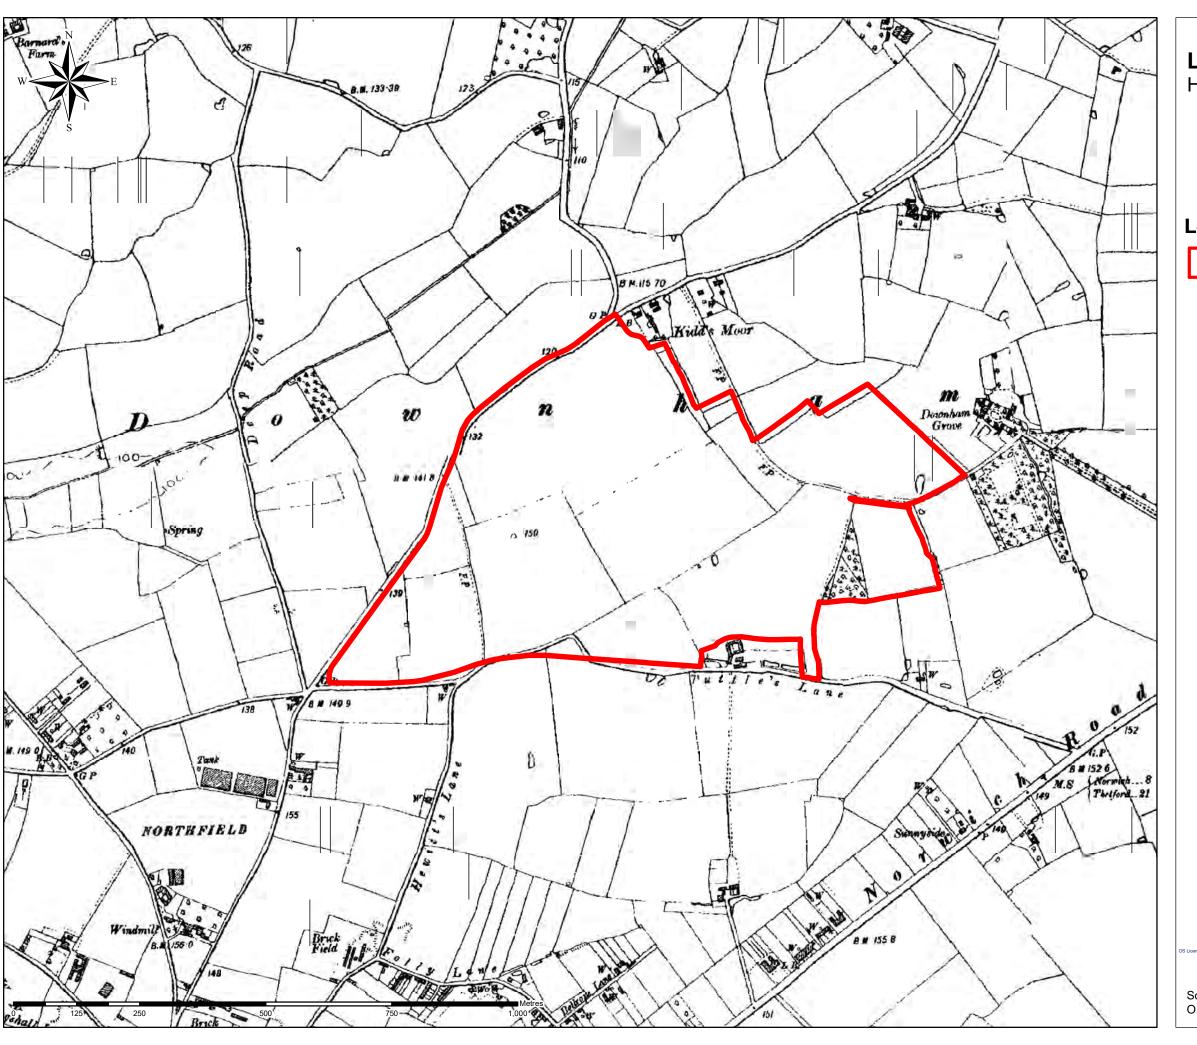
Historical - 1907

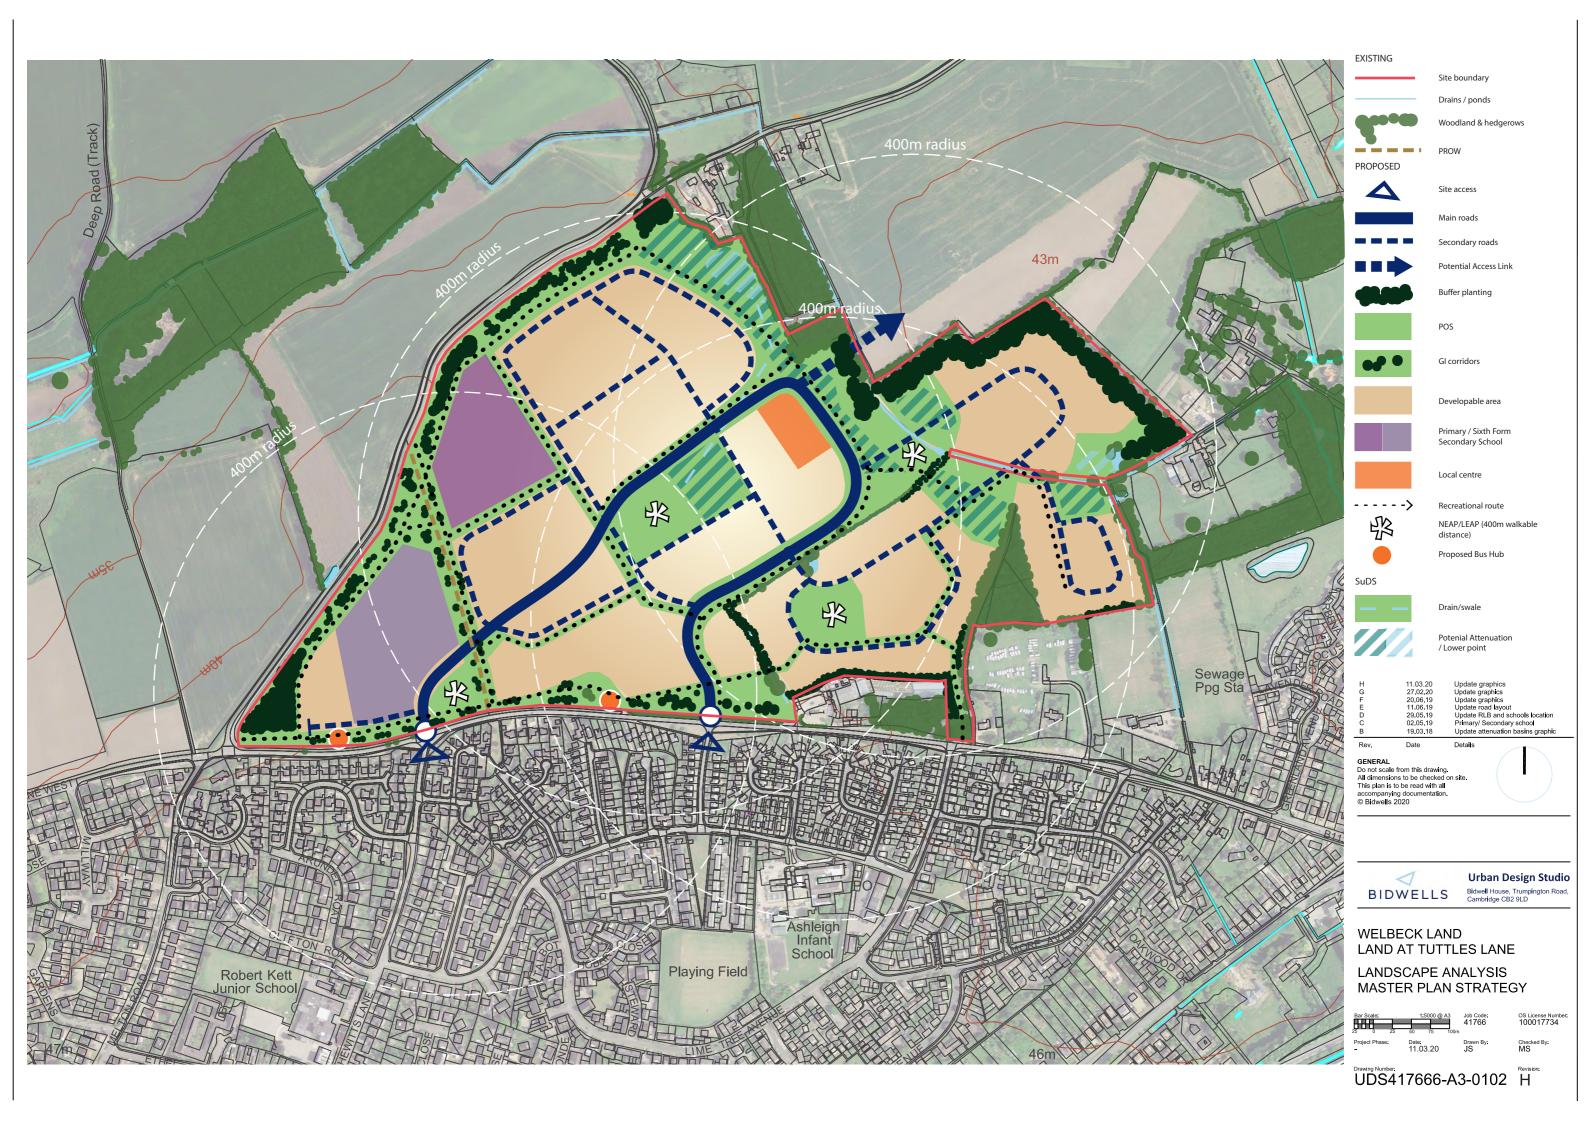
TUTTLES LANE WYMONDHAM DEVELOPMENT BRIEF				
Client: Welbeck Land				
Total Site Area	53.31 hectares			
DEVELOPMENT TYPE	Area (Hectares)	Area (SQM)	Area % of Total Site	No. of Dwellings @ 35dph
Developable Area	33.84	338,400	63.47%	-
Road infrastructure (12% of Total Site Area)	6.4	64,000	12%	-
Housing Area	22.85	228,500	42.86%	800
Primary School	2.08	20,800	4.14%	-
Sixth Form Secondary School	2.50	25,000	4.68%	
Local Centre	0.50	5,000	0.93%	
Public Open Space Provision	11.6	116,000	21.75%	-
Vegetative Buffer	6.04	60,400	11.32%	-
Area Not Developable (existing woodland)	1.21	12,100	2.15%	-
OPEN SPACE POLICY	No. of hectares per	Indicative	Open Space (Ha)	
REQUIREMENT (Wymondham AAP)	1000 people	No. People (800 x 2.4)	Requirement	Provided (11.6 + 6.04 ha)
Formal open space	0.98	1,920	1.88	
Children's and young people's play	1.96	1,920	3.76	
Natural/Semi-natural green space	5.08	1,920	9.75	
Total Open Space Provi	Total Open Space Provision (Hectares) 15.39 17.64			17.64

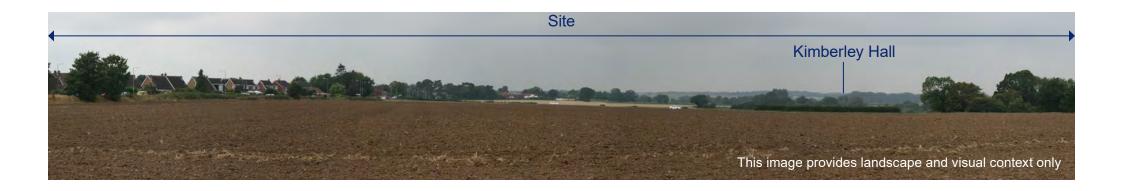
VIEWPOINT 1a - WEST: PUBLIC FOOTPATH FP6		
DESCRIPTION OF THE VIEW (0m from Site)	The photograph represents views experienced by pedestrians on a public footpath leading out of Wymondham to the north. The viewer is looking west across the River Ti ey valley. The Site is visible in the foreground, which is currently an ope eld used for agricultural purposes. To the left of the view are residential dwellings facing Tuttles Lane. The view extends a long way towards the wooded horizon line which is gently undulating.	
SENSITIVITY OF THE RECEPTORS:	Susceptibility - Visual receptors associated to this view are pedestrians on a public footpath who would appreciate the surrounding landscape for recreational reasons.	Value - The County Wildlife Sites are visible in the background and so is the woodland at Kimberley Hall Registered Park and Garden.
HIGH		
POTENTIAL CHANGES TO THE VIEW	Despite the landscape bu er provided along the footpath in the proposed master plan strategy this view will substantially change as the rural landscape will be replaced with an urban development. The long view towards the river valley would be lost.

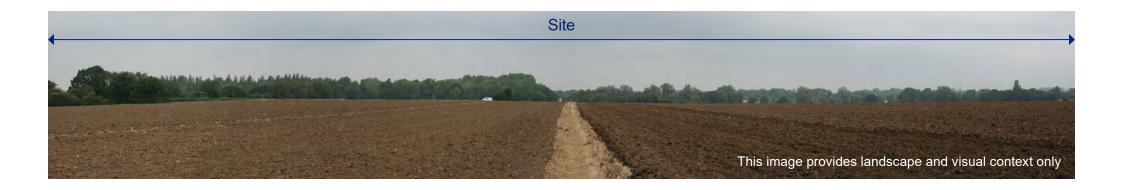
VIEWPOINT 1b - NORTH: PUBLIC FOOTPATH FP6		
DESCRIPTION OF THE VIEW (0m from Site)	The photograph represents views experienced by pedestrians on a public footpath leading out Wymondham to the north. The viewer is looking north across the Site, which currently consists of open agricultura elds. The view is enclosed in the immediate background by woodland blocks, which de ne the horizon line.	
SENSITIVITY OF THE RECEPTORS:	Susceptibility - Visual receptors associated to this view are pedestrians on a public footpath who would appreciate the surrounding landscape for recreational reasons.	Value - There are no landscape designations visible within this view, although these woodland blocks are a distinctive feature in the local landscape.
HIGH		
POTENTIAL CHANGES TO THE VIEW	The proposed development will substantially change the character of this view with the introduction of a new urban context. Although the landscape bu er along the footpath will provide some mitigation of the visual e ects of the proposal and preserve the wooded view at the end of the path, the tranquillity of the footpath would considerably diminish.

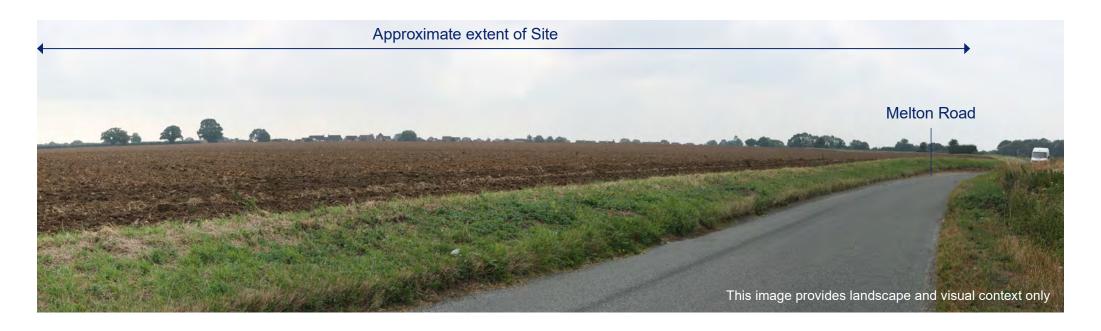
VIEWPOINT 3a: WEST - MELTON ROAD		
DESCRIPTION OF THE VIEW (6m from Site)	The photograph represents views experienced by road users travelling southward on Melton Road. The Site is visible in the foreground, which is characterised by an open rural landscape. The road is slightly sunken with grassed embankments on both sides of the road. Due to rising topography, the tree canopies on the horizon are barely visible over the led line.	
SENSITIVITY OF THE RECEPTORS:	Susceptibility - Visual receptors associated to this view are road users whose focus would not primarily be on the surrounding landscape.	Value - There are no landscape designations visible within this view, nor distinctive landscape features.
POTENTIAL CHANGES TO THE VIEW	The proposed development will change the character of the road and replacing the open rura eld.	ne view with the proposed bu er planting enclosing

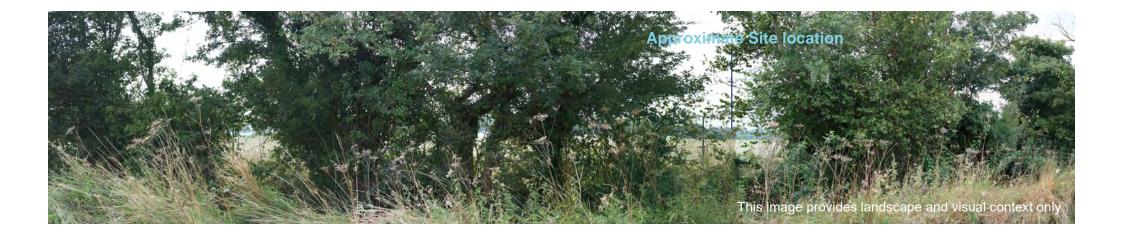
VIEWPOINT 4: PUBLIC FOOTPATH FP26		
DESCRIPTION OF THE VIEW (1.13km from Site)	The photograph represents views experienced by pedestrians on a public footpath to the north of Wymondham, linking Norwich Common to Melton Road. The view is substantially screened by the hedgerow along the footpath, with glimpses of the landscape and the new sports club facilities visible through the occasional gaps. The Site is located in the far distance and it is not visible due to intervening vegetation.	
SENSITIVITY OF THE RECEPTORS:	Susceptibility - Visual receptors associated to this view are pedestrians on a public footpath. Their attention will focus on the surrounding landscape. Value - There are no landscape designations visible within this view. Furthermore, the new sport facilities are somewhat detracting features in the landscape.	
POTENTIAL CHANGES TO THE VIEW	Although more glimpses of the surrounding landscape are cover, the proposed development is unlikely to be visible of facilities.

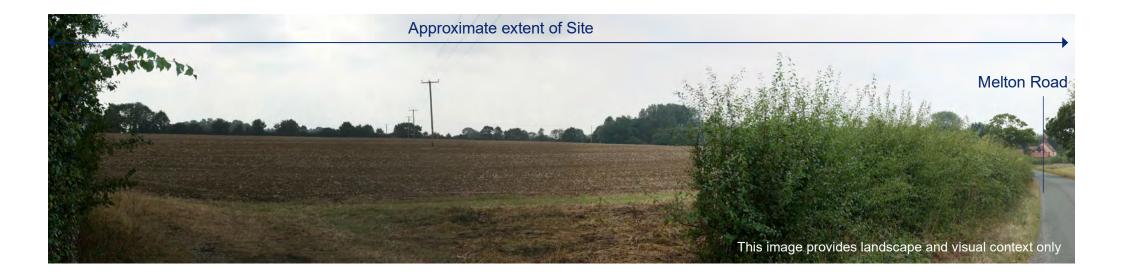
VIEWPOINT 5: MELTON ROAD		
DESCRIPTION OF THE VIEW (468m from Site)	The photograph represents views experienced by road users travelling southward on Melton Road. The Site is located in the background, beyond the hedgerow trees. In the foreground is an open agricultura eld visible through a gap in the hedgerow along Melton Road. The skyline is de ned by the tree canopies of the hedgerow which encloses the eld.	
SENSITIVITY OF THE RECEPTORS:	Susceptibility - Visual receptors associated to this view are road users whose focus would not primarily be on the surrounding landscape.	Value - There are no landscape designations visible within this view, nor distinctive landscape features.
POTENTIAL CHANGES TO THE VIEW	The proposed development is located behind the hedgerd the current hedgerow screening and, when mature, will e Before then, glimpses of the new development are likely thedgerow would not be in leaves.	ectively neutralise any visual e ects of the proposal.

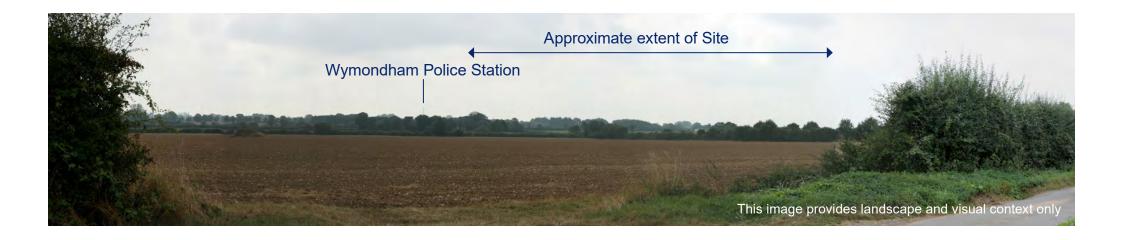
VIEWPOINT 6: GREEN LANE		
DESCRIPTION OF THE VIEW (1.7km from Site)	The photograph represents views experienced by road users on Green Lane. The viewer is looking south towards the Site, which is screened by the intervening vegetation. In the foreground is an open, agricultural eld. The wooded skyline is linear and consistent, the only detracting feature is the mast of the Police Station emerging over the horizon.	
SENSITIVITY OF THE RECEPTORS:	Susceptibility - Visual receptors associated to this view are road users whose focus would not primarily be on the surrounding landscape.	Value - There are no landscape designations visible within this view. The visible landscape consists of attractive, but not distinctive, countryside.
POTENTIAL CHANGES TO THE VIEW	Due to distance and intervening vegetation, it's unlikely the view will be substantially unchanged.	nat the proposal would be visible in the view. Therefore

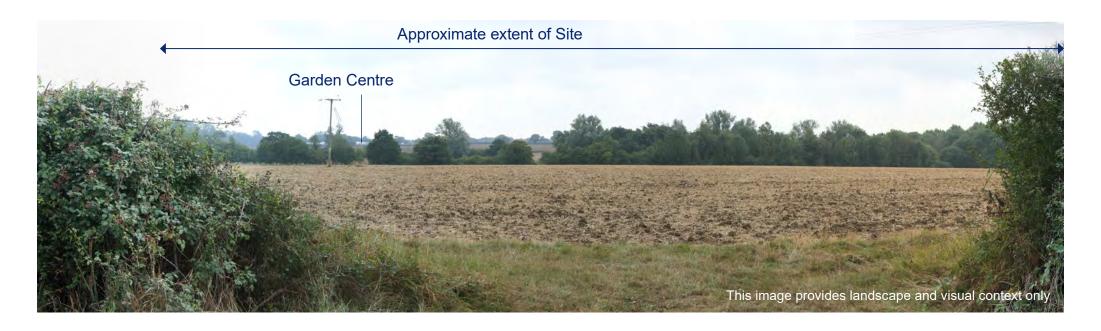
VIEWPOINT 7: YOUNGMANS ROAD										
DESCRIPTION OF THE VIEW (523m from Site)	The photograph represents views experienced by road users travelling on Youngmas Road. The Site is located in the background, and is partially screened by a block of woodland. In the foreground is an open agricultural eld visible through a gap in the hedgerow along the road. The view is partially enclosed by woodland to the right, but the long view to the left reaches Wymondham settlement edge. The skyline is largely de ned by the tree canopies.									
SENSITIVITY OF THE RECEPTORS:	the surrounding landscape. distinctive feature in the local land									
POTENTIAL CHANGES TO THE VIEW		ew already a ords glimpses of the dwellings and garden proposed bu er planting along Melton Road matures the ew to Wymondham would be lost as a result of the proposed

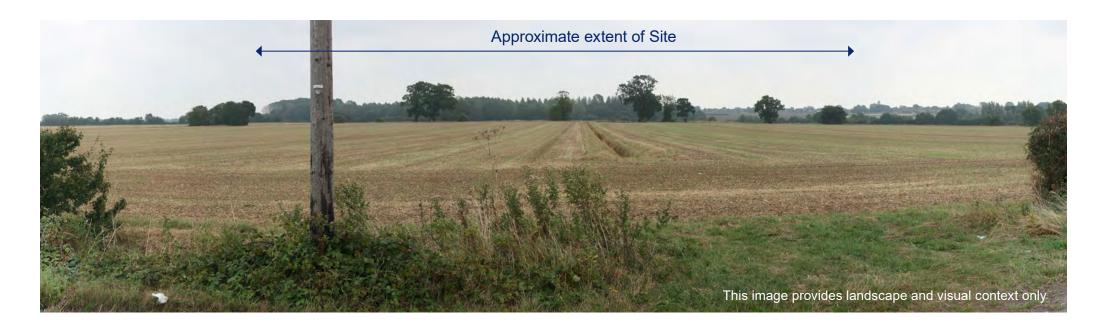
VIEWPOINT 8: BARNHAM BROOM ROAD										
DESCRIPTION OF THE VIEW (1.13km from Site)	The photograph represents views experienced by road users on Barnham Broom Road. The viewer is looking south towards the Site through a gap in the hedgerow along the road. The Site is partially screen by a woodland block to the left of the view. The agricultura elds of the Site are visible in the background to the right. Beyond it is the settlement edge of Wymondham. In the foreground is an open arabled and scattered trees. The skyline is largely linear and wooded.									
SENSITIVITY OF THE RECEPTORS:	Susceptibility - Visual receptors associated to this view are road users whose focus would not primarily be on the surrounding landscape.	Value - There are no landscape designations visible within this view, although the woodland block is a distinctive features in the local landscape.								
LOW										
POTENTIAL CHANGES TO THE VIEW	visible to the right of the view extending the visible urban However, once the proposed planting bu er along Melton	pment will be screened by the existing woodland, the proposals will be nding the visible urban character along Tuttle Lane into the rural landscape. ting bu er along Melton road will have matured, the proposal will be screened ondham will be lost but the wooded skyline character reinforced.

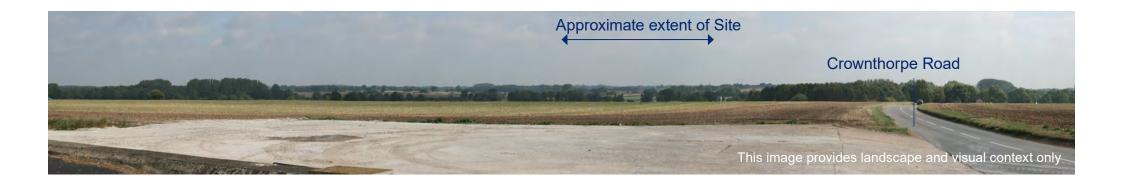
VIEWPOINT 9: CROWNTHORPE ROAD										
DESCRIPTION OF THE VIEW (2.38km from Site)	The photograph represents views experienced by road users travelling southward on Crownthorpe Road. The Site is located in the far distance and it's partially screened by the intervening vegetation. The landscape of the view is largely rural with the only interference of the road and hard surface for manoeuvring in the foreground. The wooded skyline is linear and consistent.									
SENSITIVITY OF THE RECEPTORS:	Susceptibility - Visual receptors associated to this view are road users whose focus would not primarily be on the surrounding landscape.	Value - There are local landscape designations visible within this view (County Wildlife Sites), but no other distinctive landscape features.								
MEDIUM										
POTENTIAL CHANGES TO THE VIEW	changes to the view are unlikely to be noticed by the rece	would be partially visible at the centre of the view in the far distance, therefore cely to be noticed by the receptors. Furthermore, as the proposed planting bu er ature, the proposal would be substantially screened and no changes in the view ter of the skyline would be slightly reinforced.

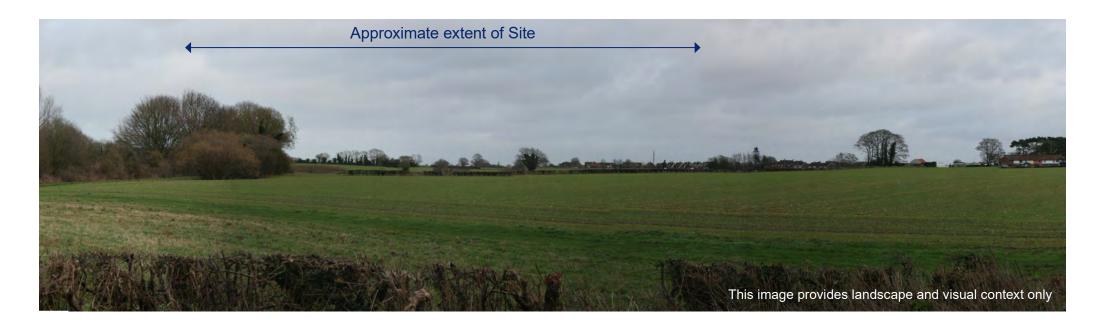
VIEWPOINT 10: BARNHAM BROOM ROAD									
DESCRIPTION OF THE VIEW (904m from Site)	The photograph represents views experienced by road users travelling southwards on Barnham Broom Road. The Site is visible in the background although views are partiall—ltered by the existing trees and hedgerows. This vegetation also de nes part of the skyline, which is otherwise characterised by the houses on the northern edge of Wymondham. The open agricultura—eld is a prominent feature of the view, however, the hedgerow in the foreground was recently trimmed and when grown back would provide substantial screening to the view.								
SENSITIVITY OF THE RECEPTORS:	Susceptibility - Visual receptors associated to this view are road users whose focus would not primarily be on the surrounding landscape.	Value - The woodland to the left is a County Wildlife Site, but no other designations or distinctive landscape features characterise the view.

POTENTIAL CHANGES TO THE VIEW		the background, particularly before the proposed planting has will be minimal with a reinforced woodland horizon and glimpses I the character of the view will be retained.

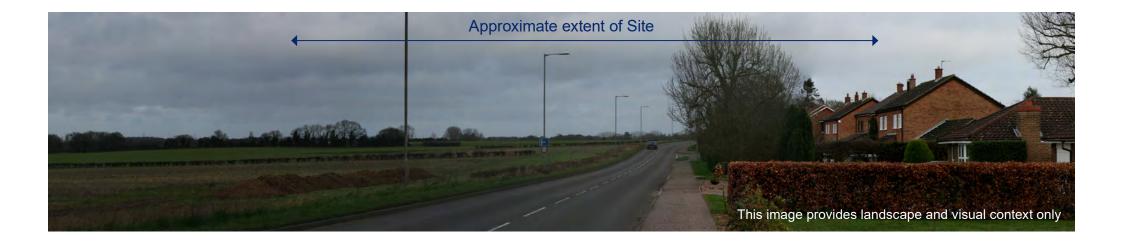
VIEWPOINT 11: TUTTLES LANE WEST									
DESCRIPTION OF THE VIEW (366m from Site)	The photograph represents views experienced by road users travelling eastwards on Tuttles Lane West. Part of the Site is visible at the centre of the view, in the background, with some screening a orded due to existing hedgerows and hedgerow trees, as well as intervening built form. To the right of the view is the urban edge of Wymondham with houses fronting the open countryside. The view is almost equally split between the elds enclosed by hedgerows and the built form. The skyline is equally split between the two characters.								
SENSITIVITY OF THE RECEPTORS:	Susceptibility - Visual receptors associated to this view are road users whose focus would not primarily be on the surrounding landscape. However, pedestrians and cyclists at lower speed would engage more with the surrounding landscape. Value - There are no designations visible in the and the urban character is detracting from other landscape qualities.

POTENTIAL CHANGES TO THE VIEW	The proposed development would be visible in the background, particularly before the proposed planting has matured. Similarly, the skyline will see an increase of urban features whilst the proposed planting has not matured. While the foreground of the view will remain unchanged, the extended urban character will replace the ope elds in the background reducing the distance to the perceived horizon line.

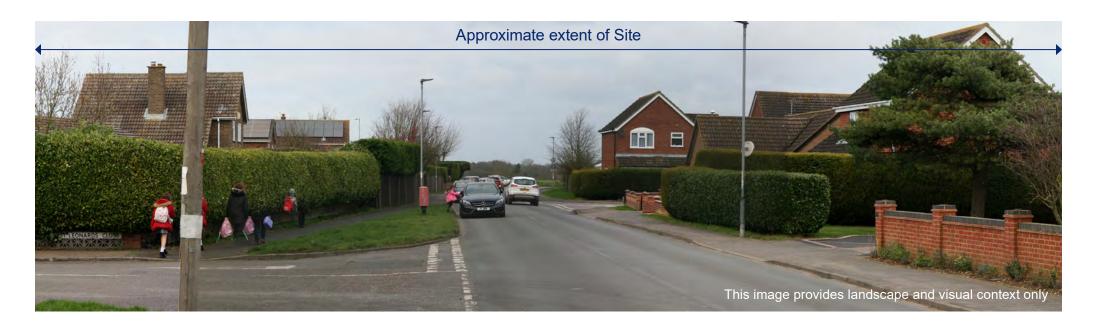
VIEWPOINT 12: HEWITTS LANE										
DESCRIPTION OF THE VIEW (142m from Site)	The photograph represents views experienced by road users travelling northwards on Hewitts Lane. Most of the Site is screened by the intervening built form to the side of the road. However, a small portion is visible at the centre of the view, framed by the existing houses. The long view crosses the Site and ends at the woodland block to the north-west of it.									
SENSITIVITY OF THE RECEPTORS:	Susceptibility - Visual receptors associated to this view are road users whose focus would not primarily be on the surrounding landscape. However, pedestrians, particularly residents, and cyclists at lower speed would engage more with the surrounding landscape. Value - There are no designations visible in the view and the urban character is detracting from other landscape qualities.									
POTENTIAL CHANGES TO THE VIEW	The proposed development would be visible in the background framed by existing housing. The only view towards the countryside will therefore lose such character, with an increased urban extent across the whole viewpoint. However, as proposed mitigation planting matures, the proposed built form would be softened by the tree canopies. The skyline will retain the largely urban connotation, however, there will be a loss of the only portion of wooded character where the current view extends across the Site.
