Scale at A1	Project Number
1:250	2219-413

Existing Topographic Survey

Client	Scott Properties Graham McCormick
Project	Land at Marriots Way, Taverham, Norwich
Title	Existing Ground Level Survey Sheet 26

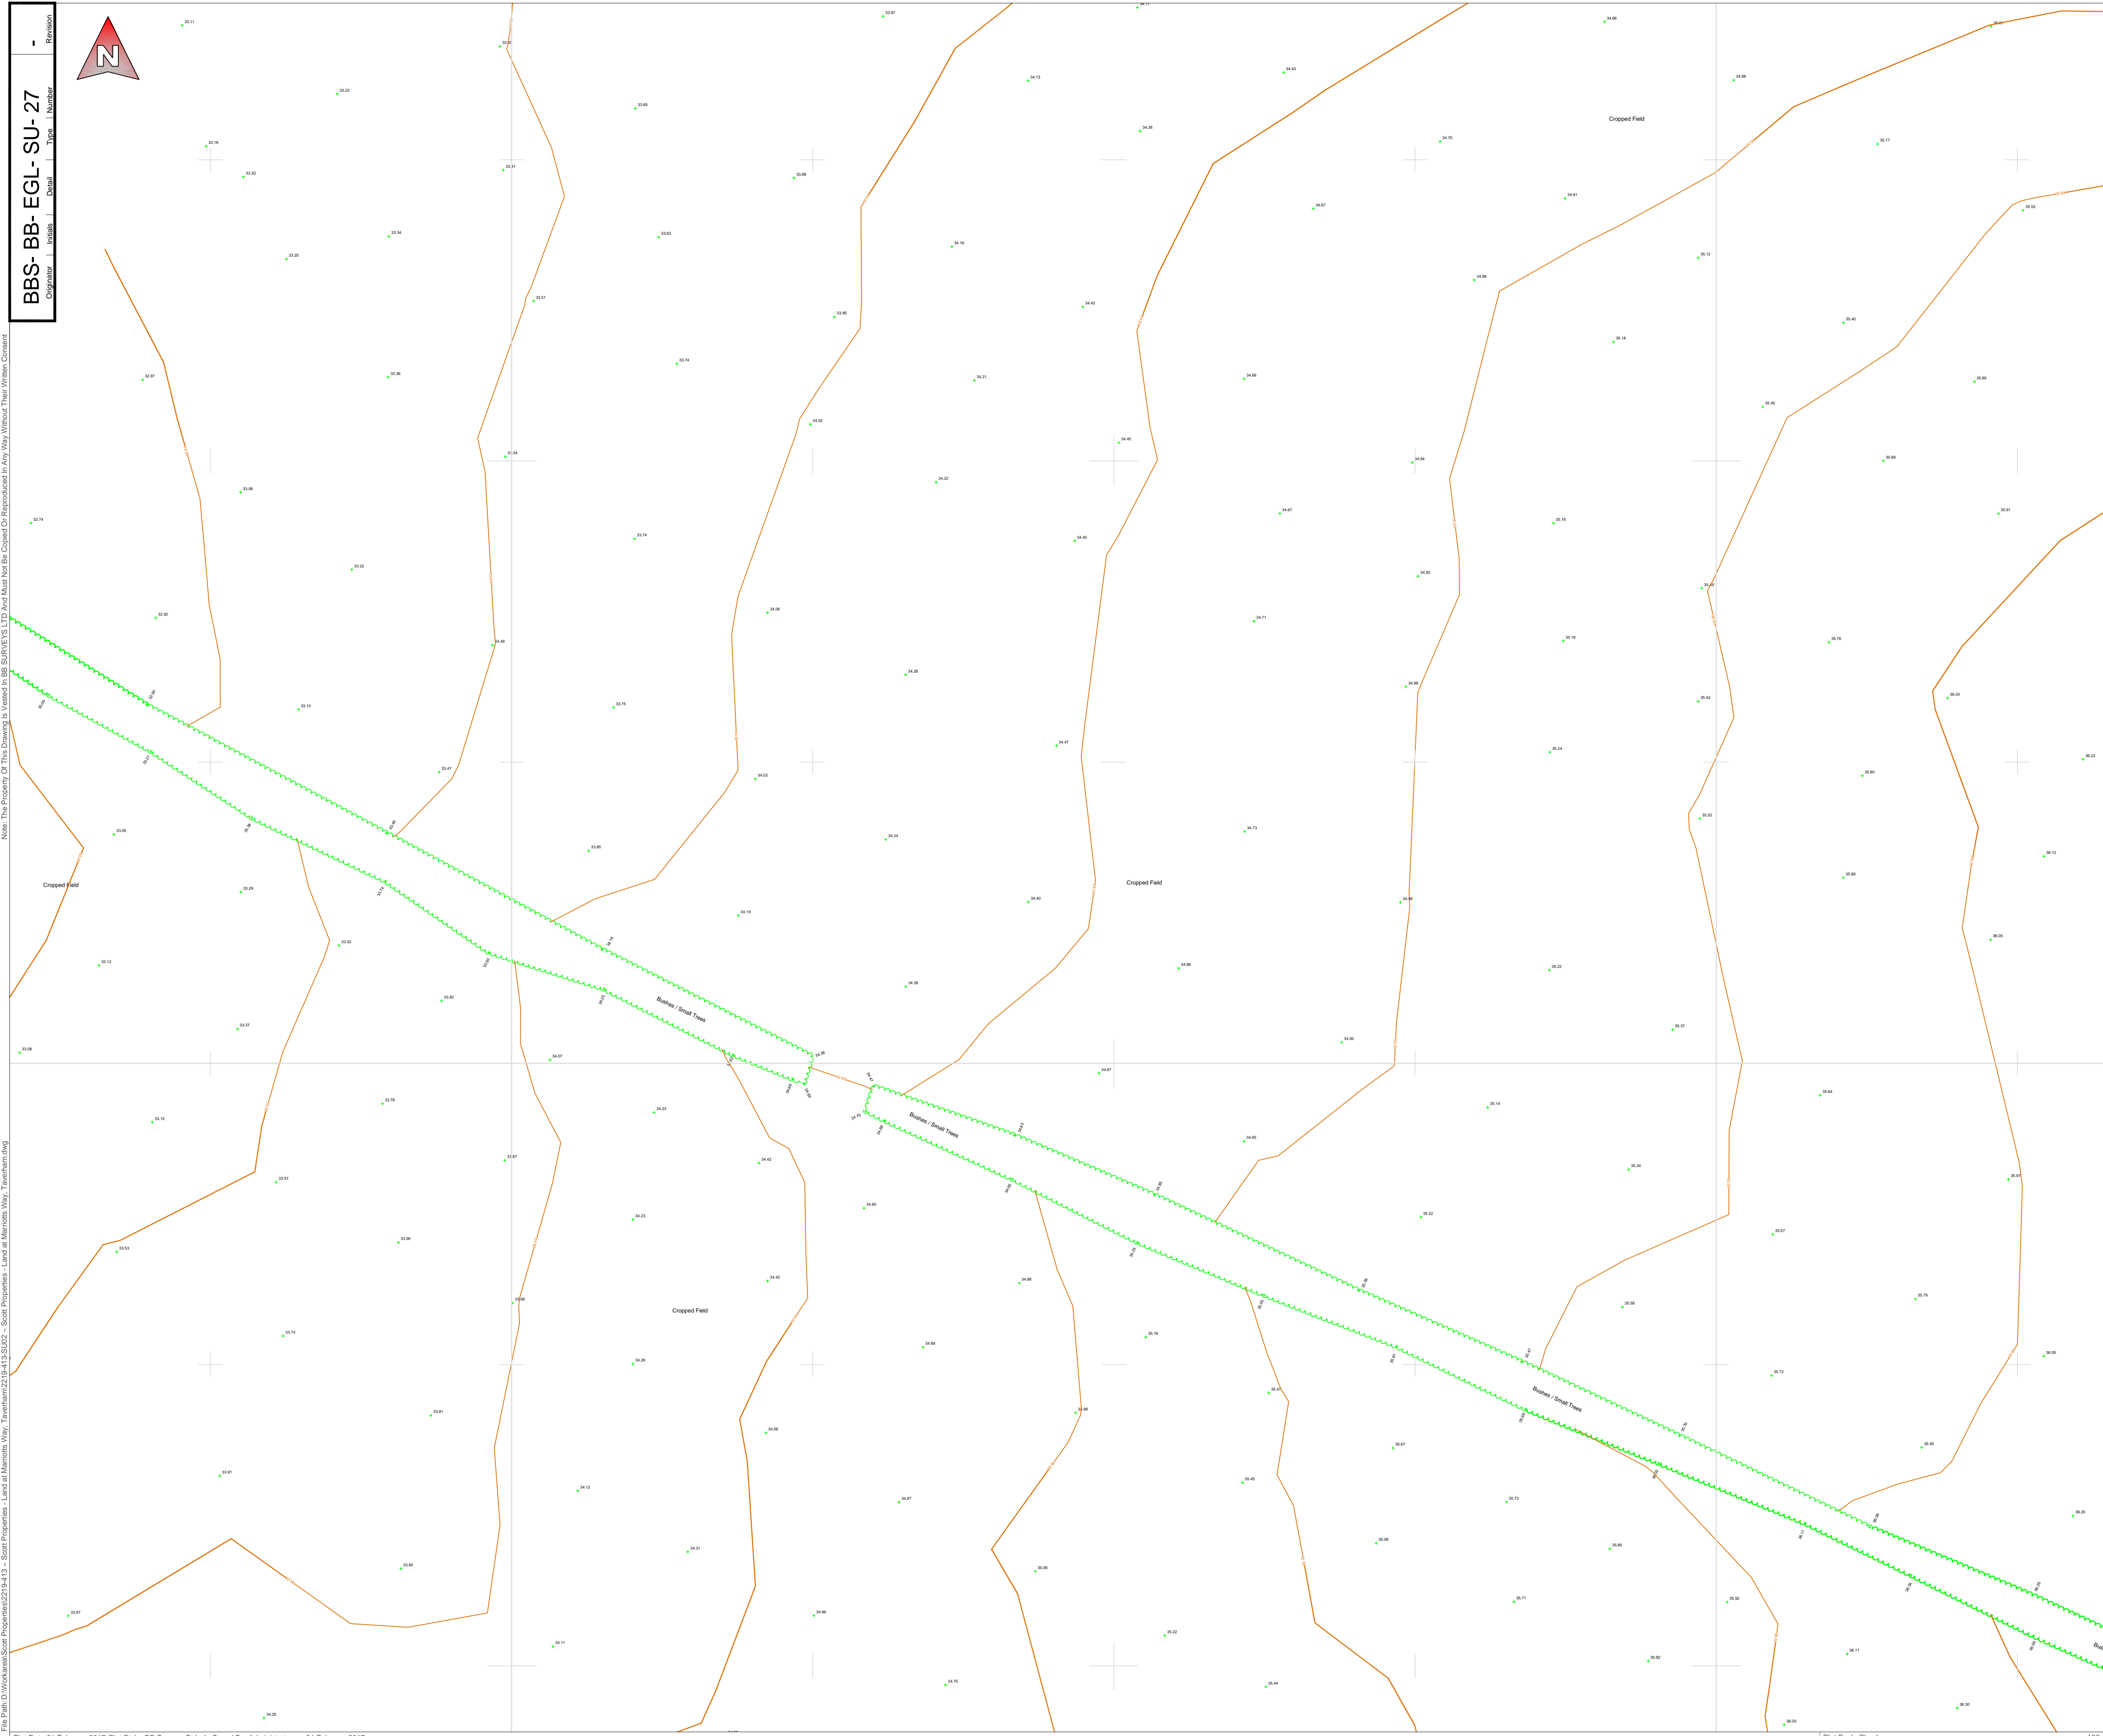
SURVEY CARRIED OUT USING TRIMBLE S8 TOTAL STATION & TRIMBLE R10 GPS. ALL SURVEY DATA TO ORDINANCE SURVEY NATIONAL GRID (OSN15). ALL DIMENSIONS ARE IN METRES UNLESS OTHERWISE STATED. ANY CRITICAL DIMENSIONS AND MEASUREMENTS SHOULD BE BASED ON THE ORIGINAL DIGITAL DATA AND CONFIRMED WITH BB SURVEYS LTD. ANY ERRORS SHOULD BE NOTIFIED TO BB SURVEYS LTD.

NO ATTEMPT HAS BEEN MADE TO ENTER ANY CONFINED SPACES ON THIS SITE. WE HAVE MEASURED INVERT DEPTHS, ESTIMATED PIPE SIZES AND SHOWN THE DIRECTION OF FLOW ONLY WHERE DRAIN RUNS ARE ACTIVE AT THE TIME OF SURVEY. INSPECTION COVERS WHICH WE WERE UNABLE TO LIFT BY MANUAL METHODS ARE DENOTED AS MH (D/L). WE DO NOT QUOTE FOR THE USE OF HYDRAULIC LIFTING EQUIPMENT.

DRAINAGE RUNS BETWEEN INSPECTION COVERS HAVE NOT BEEN INVESTIGATED. ANY SHOWN ARE ESTIMATED AND NOT CONFIRMED. ALL DRAINAGE RUNS SHOULD BE PROBED BY DYE TRACING AND, IF NECESSARY BY RADIO DETECTION METHODS PRIOR TO ANY DESIGN WORK. ALL PIPE SIZES AND CONNECTIONS SHOULD ALSO BE CONFIRMED WITH YOUR LOCAL DRAINAGE AUTHORITY PRIOR TO ANY DESIGN WORK.
